River Wensum restoration strategy

First published 26 June 2009

In 2004, a geomorphological appraisal of the River Wensum was carried out by Geodata Services, University of Southampton. JBA Consulting used these results to prepare this technical report and restoration strategy.

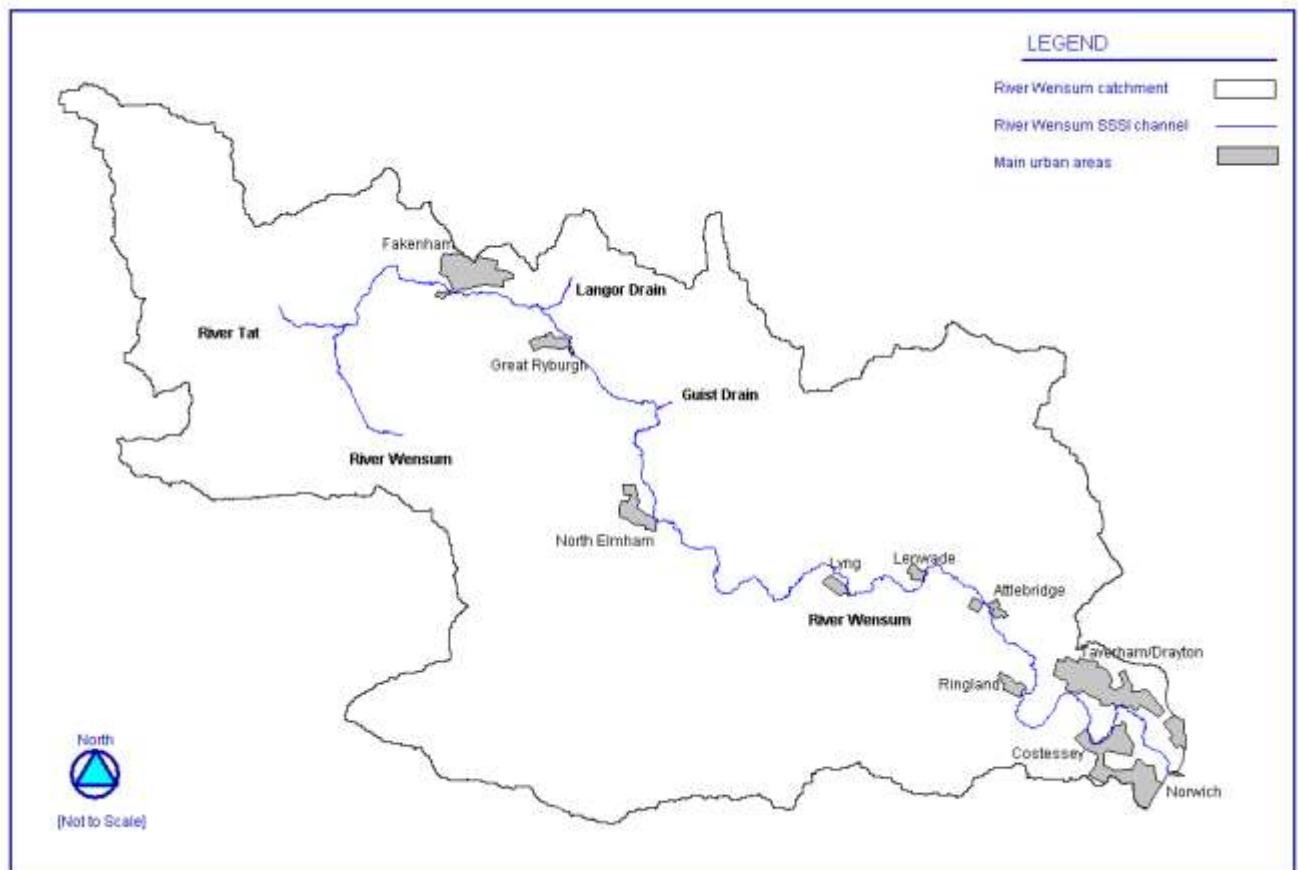
Figure 1 Location of study area

NOTE: Only the SSSI channel is shown. Other watercourses/tributaries have been omitted.

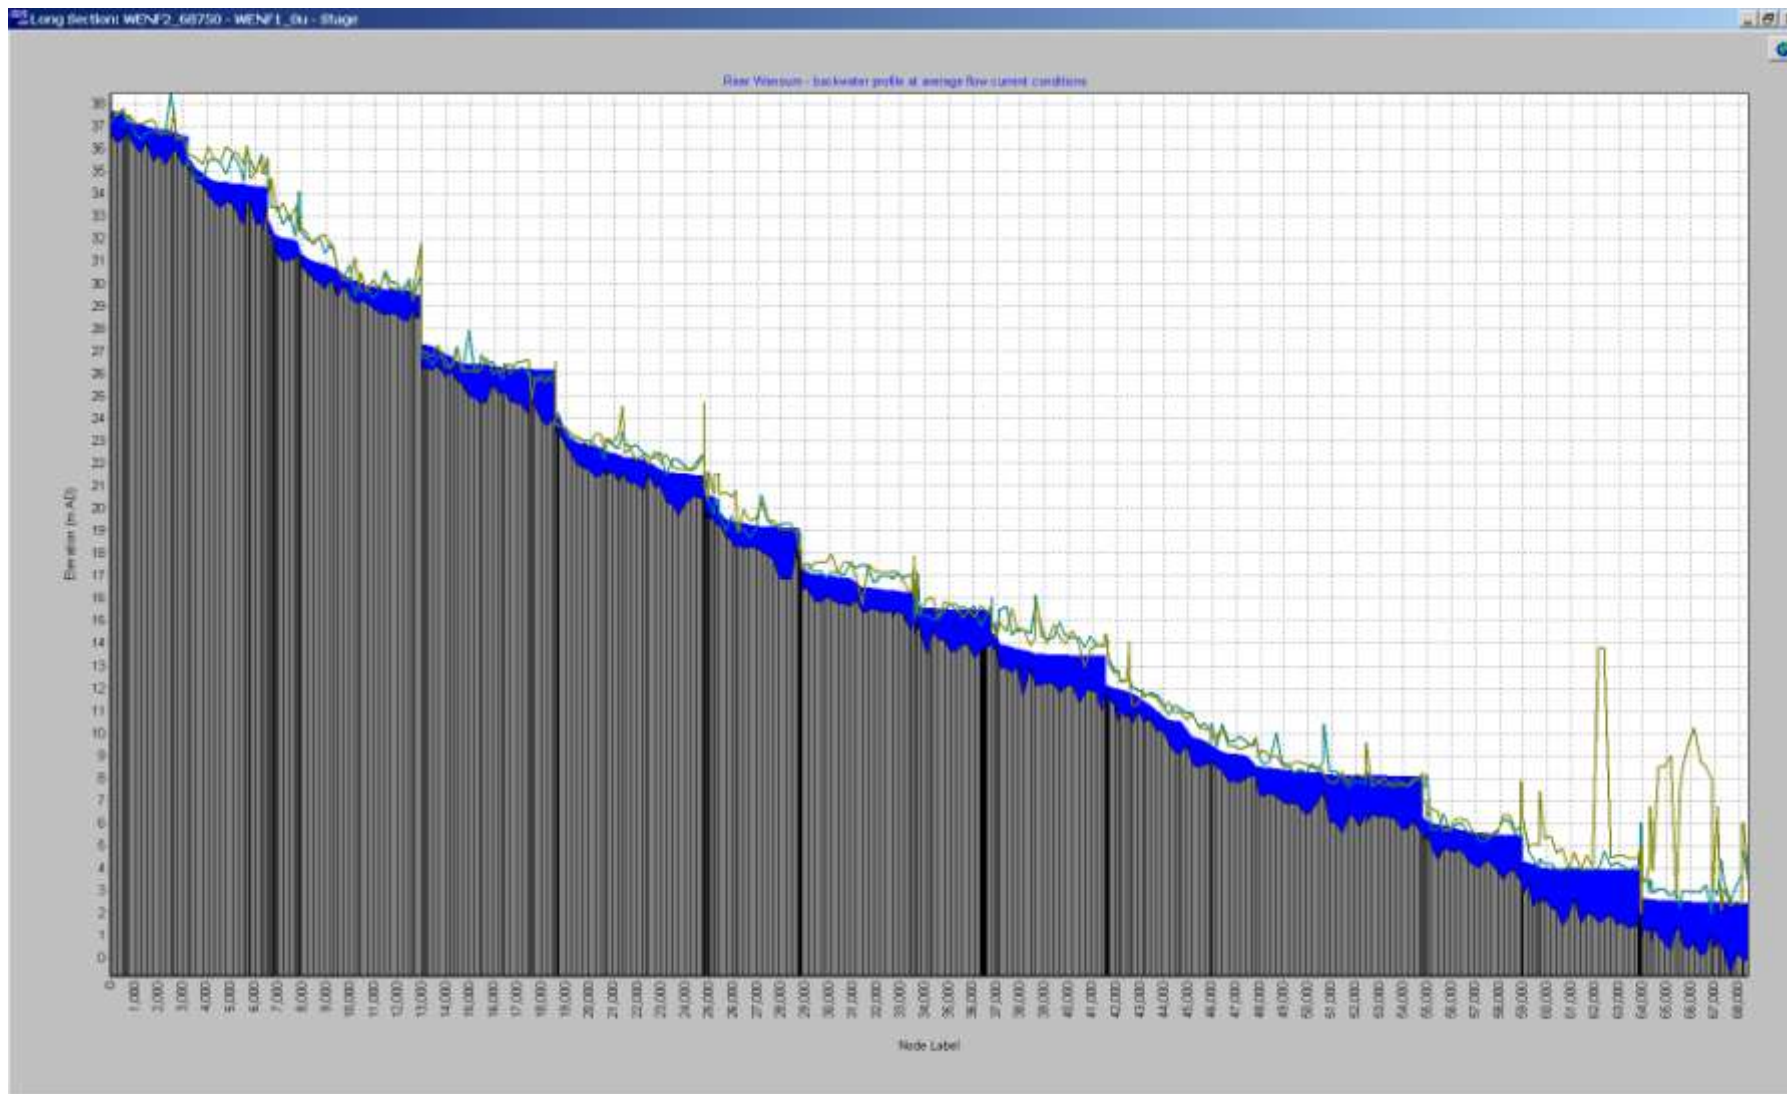
Figure 2 Long profile of the River Wensum showing average flow

- 2.10 Out of a total fall in water head along the Wensum of 34.2m (from above Sculthorpe Mill to downstream of Hellesdon Mill), 60% of the drop occurs at mill structures, rather than occurring progressively along the channel. The result is a stepped profile, with impounded reaches upstream of mills and short, steeper reaches downstream. Between Shereford and Hellesdon, 67% of the River Wensum (45.7km) is affected by backwater conditions (Figure 3 and Table 2). Due to the relatively small distance between many of the mills, there is an almost uninterrupted impoundment of river channel between Sennowe Hall (upstream of Bintry Mill) and Lenwade. The longest stretch of river with no backwater effect is between Lenwade and Ringland. This is because the distance between Lenwade and Taverham mills is relatively large (13.2km) and the channel is able to recover and maintain a more naturally functioning regime downstream of Lenwade before being influenced by the ponded water upstream of Taverham Mill.

Note: Grey area is bed level; blue area shows water level at average flow; green lines represent top of banks.

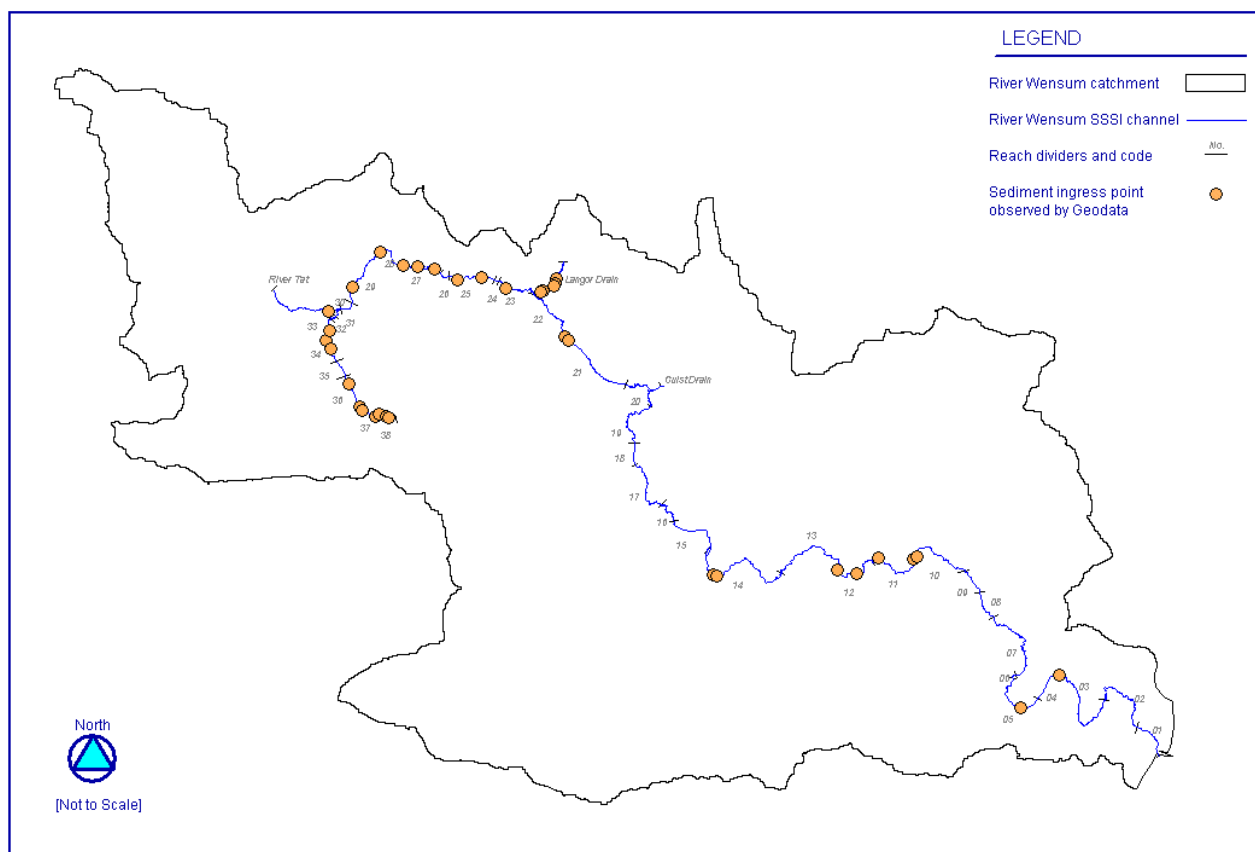
- 2.12 Figure 4 shows locations throughout the catchment where the Geomorphological Appraisal identified points of sediment ingress into the river channel. The main sources of sediment are the headwater reaches of the river, where the floodplain is relatively narrow and unable to act as an adequate buffer between the arable fields and the river, and at the confluence with some of the tributaries. Silt from the tributaries is transported from their own headwaters and, in the case of smaller water bodies, can also be derived from direct runoff into the channel from the surrounding land. It is also apparent that during rainfall events, the road network becomes an extension of the drainage system that can act as a conduit for the transportation of sediments between wider catchment sources and the Wensum or its tributaries. Sources and points of entry are summarised in Appendix 3. Overall, fine sized sediments are the main source of materials from the catchment.

Note: For larger version of this figure (A4-size), refer to Appendix 11 at back of this report. Data from GeoData (2006).

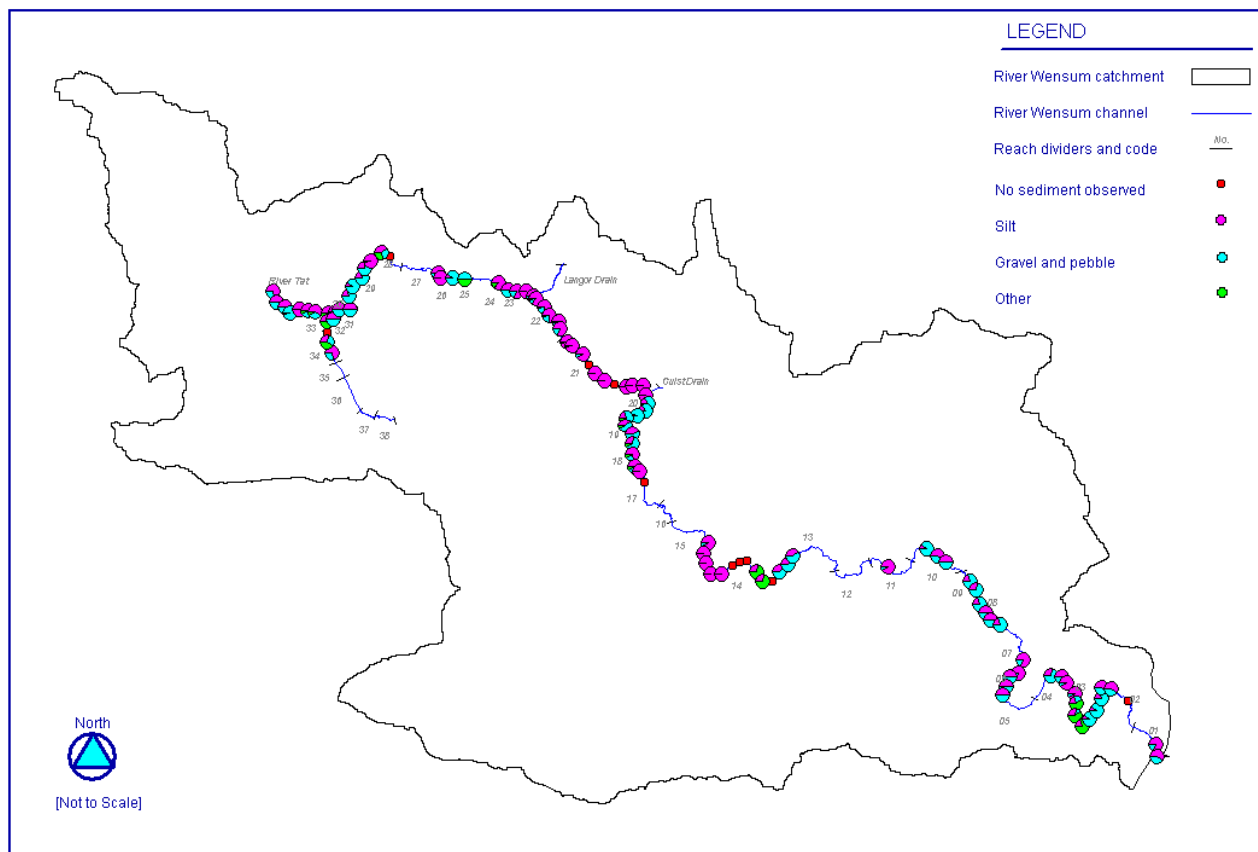
2.15 In Figure 5 the types of bed sediment observed during the macrophyte survey (2002) are shown. Many locations appear to be predominantly silty, such as along the River Tat and between Fakenham and Elsing, although there are areas where the bed was composed largely of gravel (downstream of Sculthorpe, Fakenham, Bintry and Elsing mills and in the free-flowing stretch downstream of Lenwade Mill). It is to be expected that sediment (particularly fines) is mobilised by high in-bank flows in a natural river. However, where velocity is reduced by ponding (for example, upstream of mills) deposition will occur and will be a significant factor affecting the condition of the river.

Note: For larger version of this figure (A4-size), refer to Appendix 11 at back of this report. Data from Macrophyte Survey (2002).

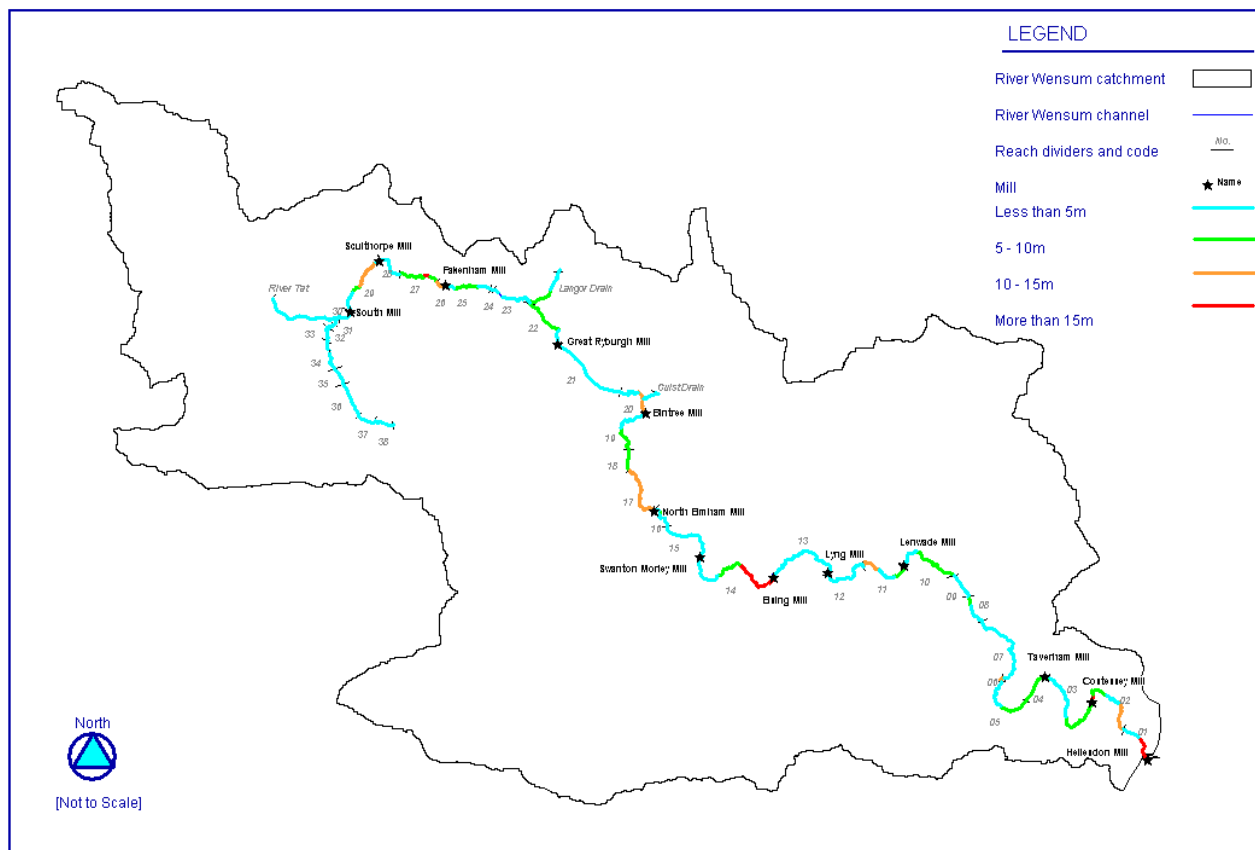
- 2.21 Figure 7 shows the extent of narrowing that is required along the River Wensum to return bankfull widths to a more natural condition. Given that chalk streams generally have a large width to depth ratio compared to other UK gravel bed rivers, these requirements are based on width calculations for banks with erodible materials. Initial calculations in the River Wensum and River Tat suggest that approximately 65% of the channel requires less than a 5m reduction in width, 21% requires between 5 and 10m reduction and 14% more than a 10m reduction to return it to an average semi-natural condition. Narrowing requirements are greatest upstream of mills, though some degree of narrowing is generally required throughout the length of the SSSI (Figure 7).

Note: For larger version of this figure (A4-size), refer to Appendix 11 at back of this report.

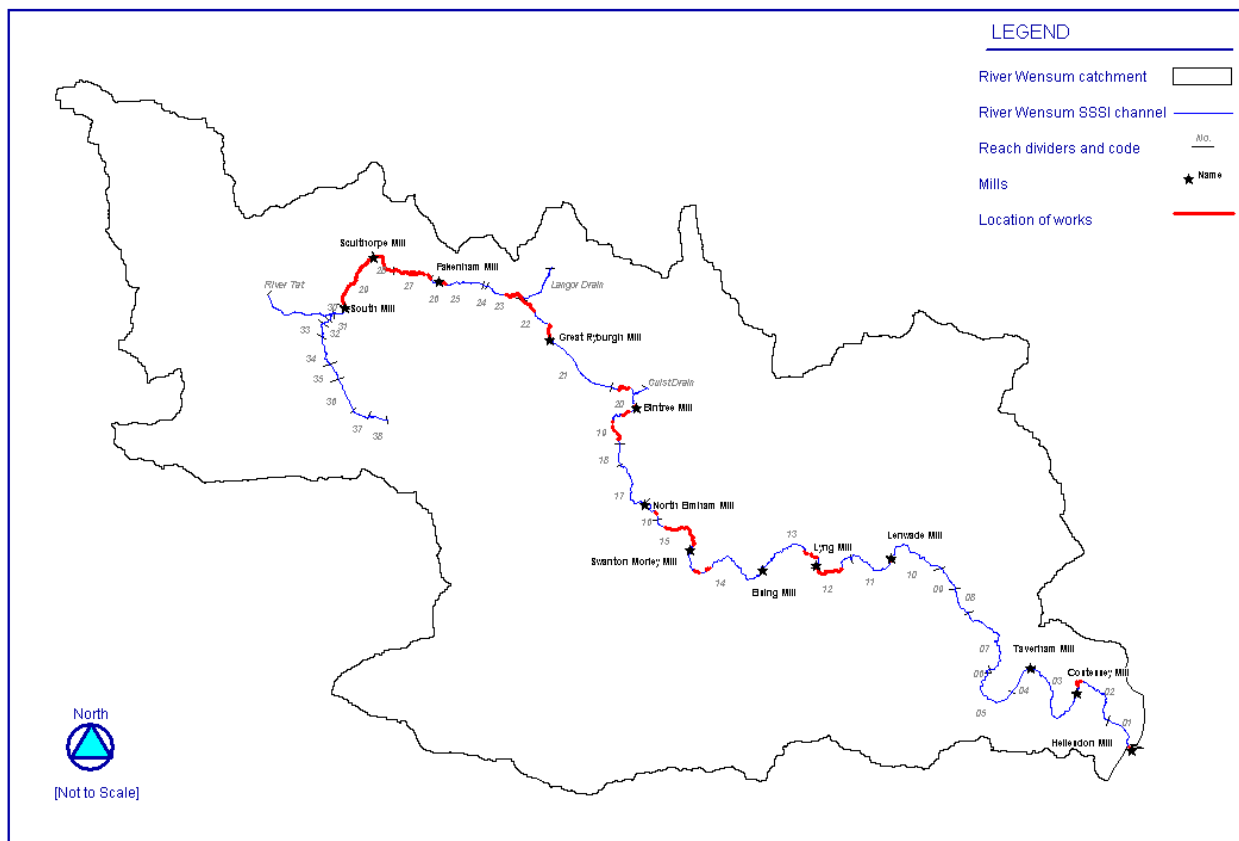
Figure 12 Works consented/undertaken by the Environment Agency since the 1990s

Note: For larger version of this figure that is annotated with descriptions of the various restorations and other works on the river (A4-size), refer to Appendix 11 at back of this report. Information provided by the Environment Agency.

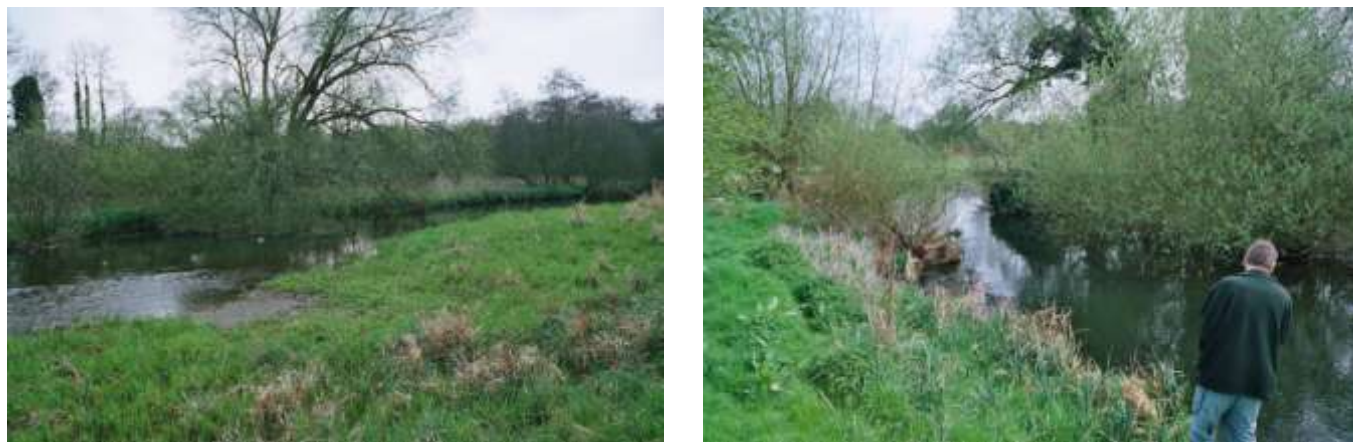
Plate 2 Previous rehabilitation sites - Lyng. Left: Downstream Lyng Mill - riffle, Right: Downstream Lyng Mill - pool

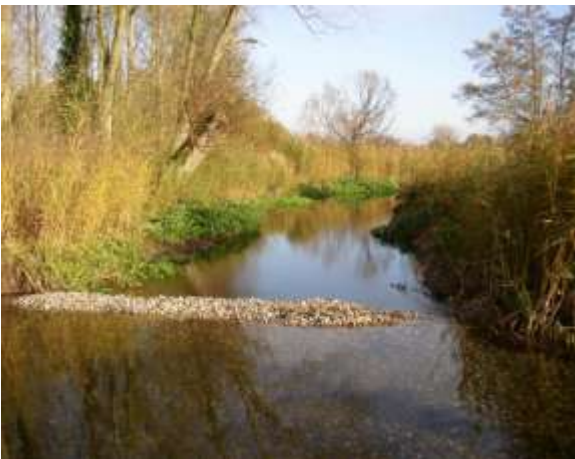
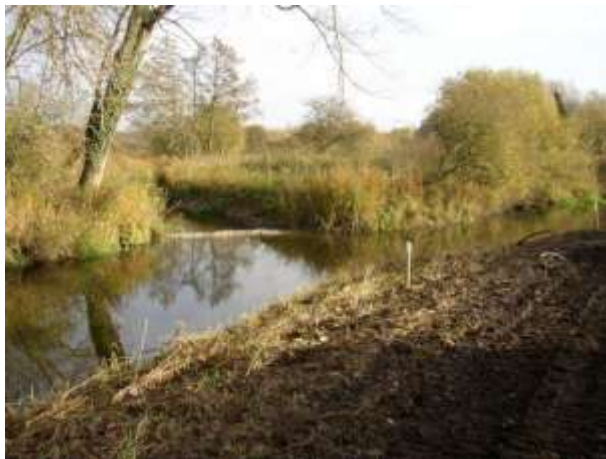
Plate 4 Consented works - Hempton. Left: Upstream Hempton site - entrance to meander, Right: Upstream Hempton site - entrance to meander

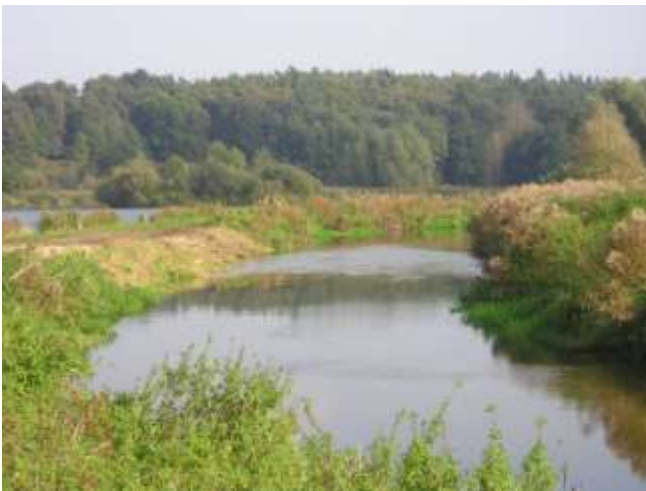
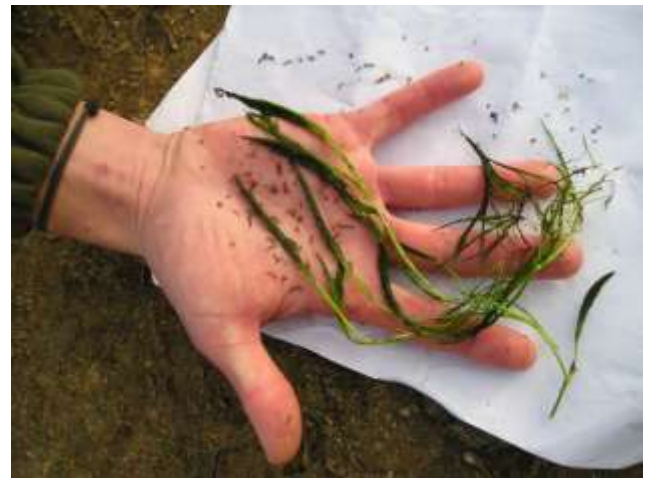
Plate 6 Consented works - Swanton Morley. Left: Swanton Morley restoration - lower riffle, Right: Swanton Morley restoration - water crowfoot

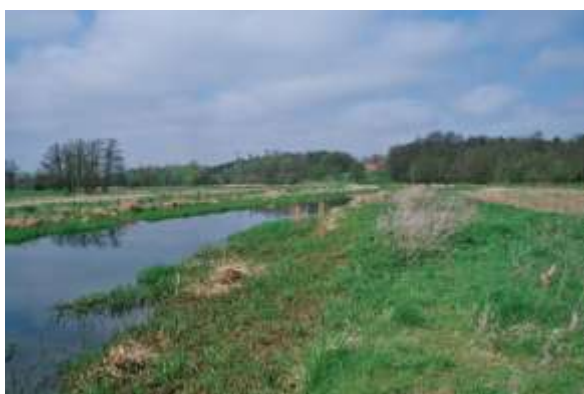
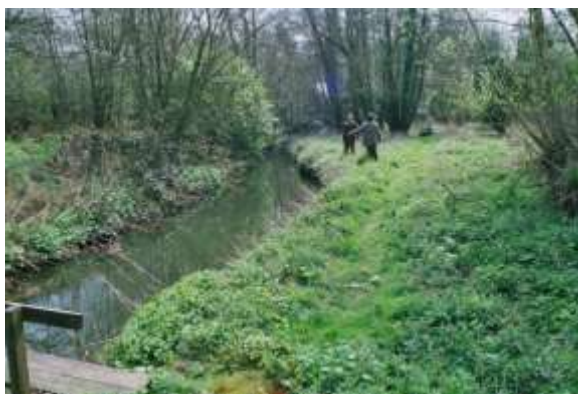
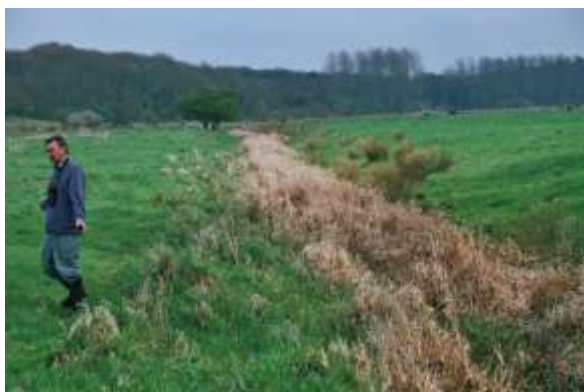
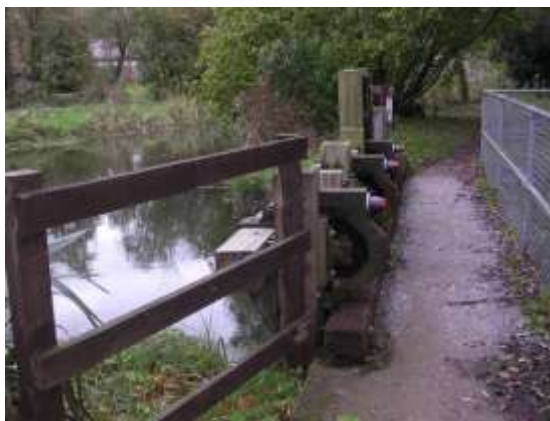
Plate 8 Potential pilot sites for restoration - Top Left: Upstream of Lyng Mill - present channel, Top Right: Upstream Lyng Mill - old course Bottom Left: Downstream Great Ryburgh Mill - old course, Bottom Right: Taverham Mill - sluice
