Appendix 2 Mill summary sheets

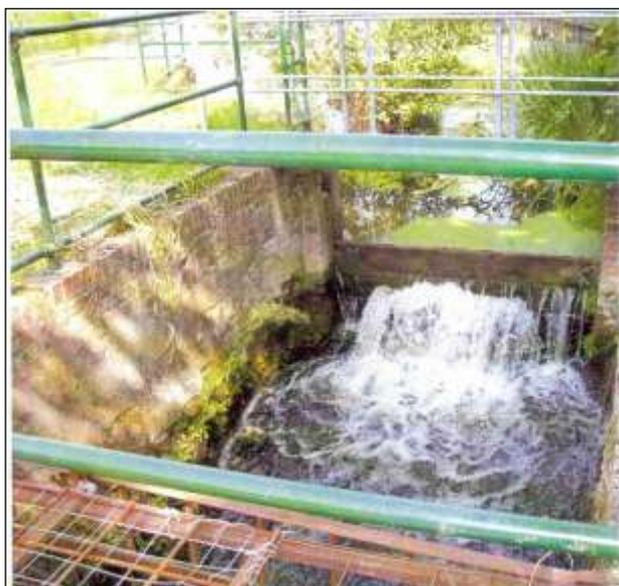
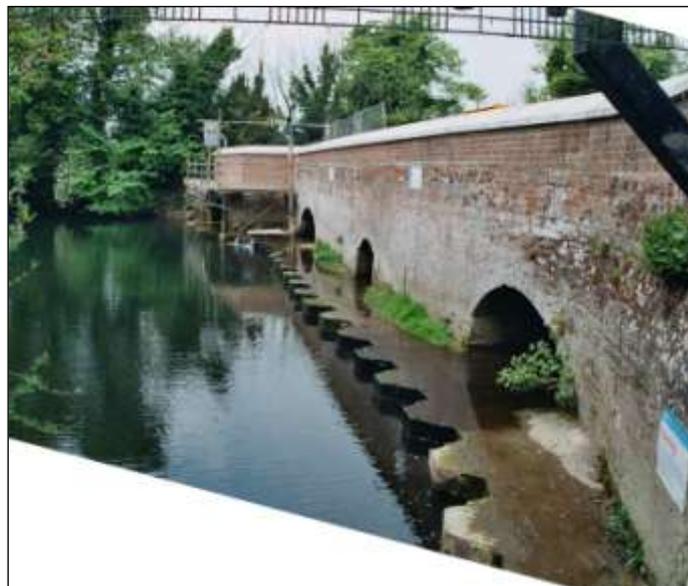
Plate Ba1 Left: View of one of the fixed weirs at Hellesdon Mill: Right: Hellesdon Mill viewed from downstream

Water control level:	3.85m AOD
Drop:	1.21m (to 2.64m AOD)
Length of backwater upstream:	5km (100% reach)
Main structure:	Block A: 1 flume with a steel control sluice and a horizontal steel penstock plus 3 fixed weirs with stop-log facilities and weed screens; Block B: An automated, bottom hinged overshot tilting gate. Invert 2.52m AOD
Operation of main structure:	Block A: Permits majority of flow to enter the section below the mill. Sluice only used during high flows in conjunction with Tud sluices; Block B: Controls mean water level upstream in the River Wensum.
By-pass structure:	Tud sluice acts as bypass channel - see below
By-pass structure operation:	Automated
Gauging station:	None

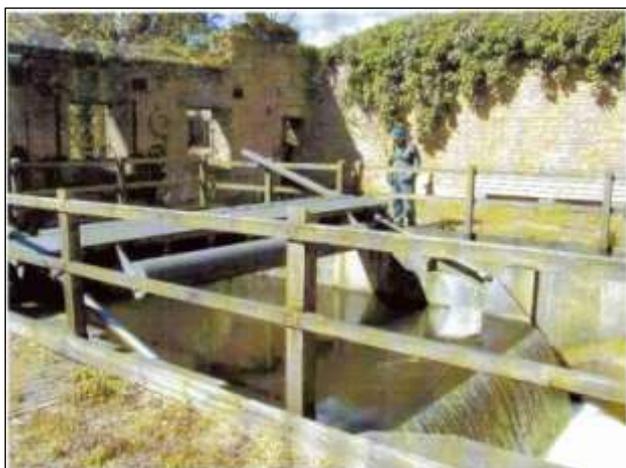
Plate Bb1 Left: Automatic tilting gate within Costessey Mill: Right: Costessey horseshoe weir under construction

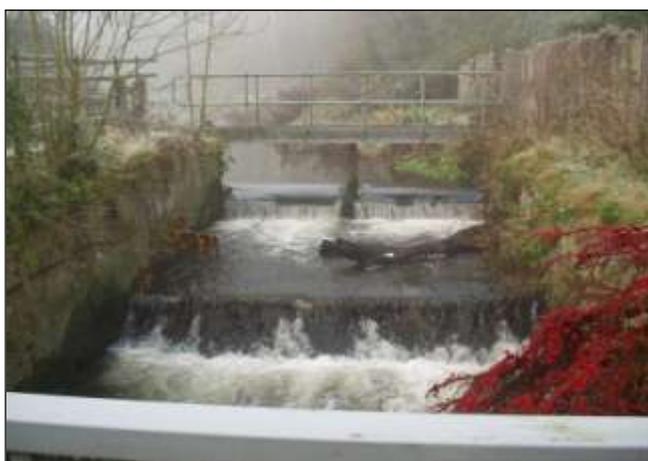
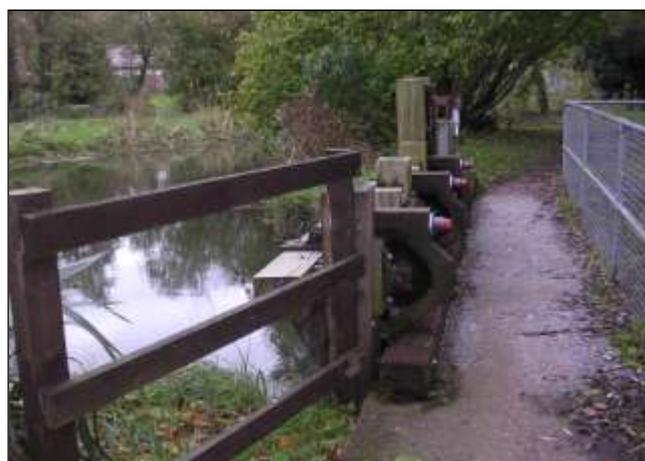
Plate Bc1 Left: View of weir (Structure #8) at site of Taverham Mill from downstream: Right: Sluice on right bank of Wensum upstream of Taverham Mill site (Structure #2)

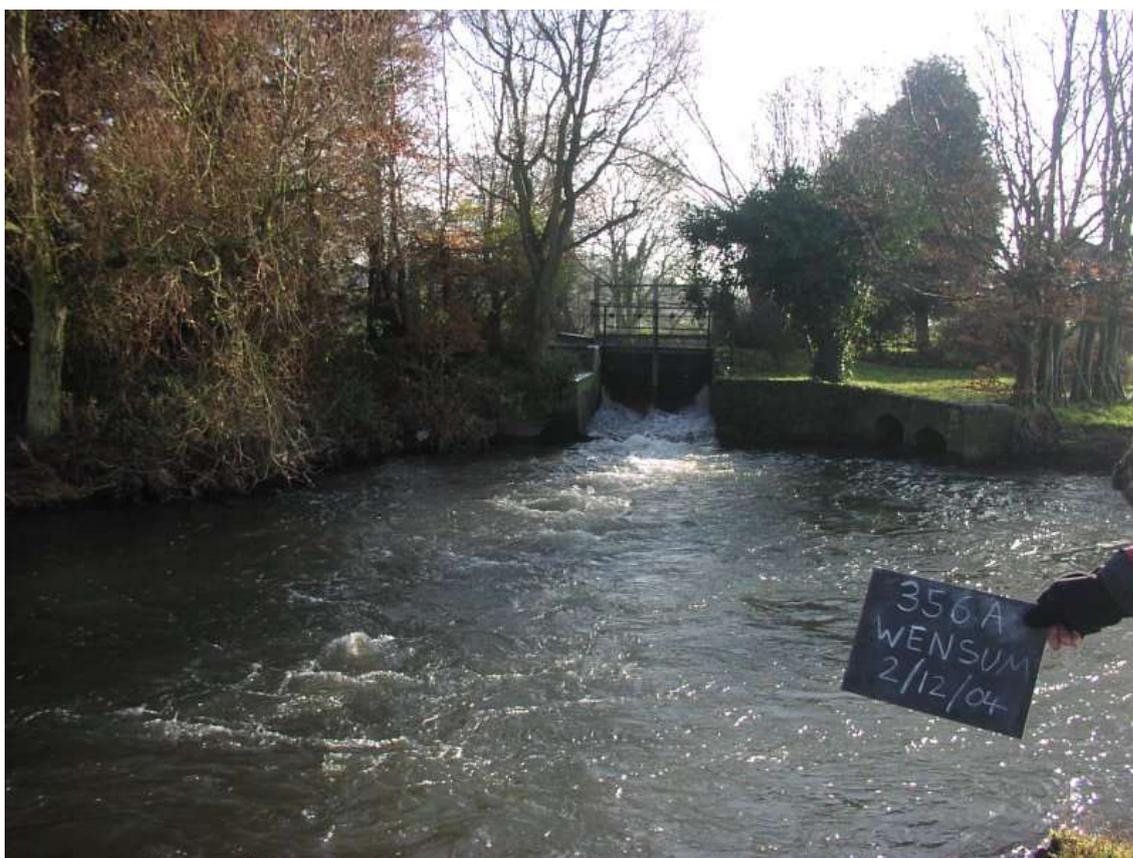
Plate Bf1 View of by-pass sluices at Elsing Mill from downstream (photo from GeoData, 2006)

Water control level:	17.5m AOD (estimated)
Drop:	1.85m
Length of backwater upstream:	4.7km (94% reach)
Main structure:	Two vertical lifting gates at mill, plus fixed with wooden board weir in wheel-race.
Operation of main structure:	Constantly observed and adjusted as necessary when wet as there is limited freeboard.
By-pass structure:	One vertical lifting gate (100m upstream).
By-pass structure operation:	Vertical lifting gates opened in flood on by-pass channel.
Gauging station:	None
Additional notes:	Main channel and by-pass impassable to fish although pools have good habitat potential.

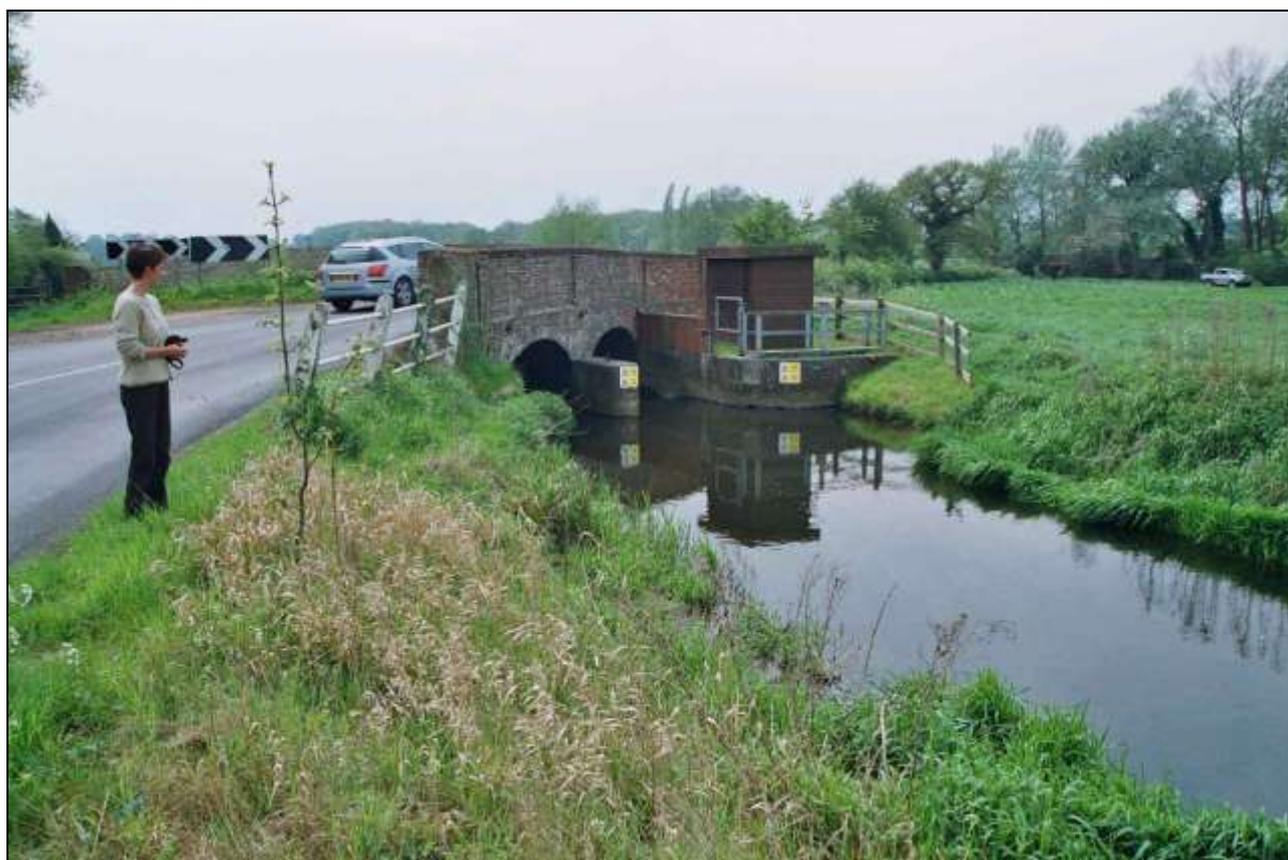
Plate Bg1 View of side channel weir at Swanton Morley

Main recommendations:	The weirs at Swanton Morley are complex as the main channel has a modern crump profile compound weir beneath three arches of the road bridge and the remnants of the original weir upstream which has a further drop of 0.6-1.0m. If the original weir (which is already damaged) is lowered then there is a danger that the side channel could dry at low flows. It is thus proposed that initially the original mill weir is notched such that upstream levels are reduced by approx 0.5m. The side channel weir should also be lowered by a similar amount which would mean breaking out and recasting the profile of the weir.
-----------------------	--

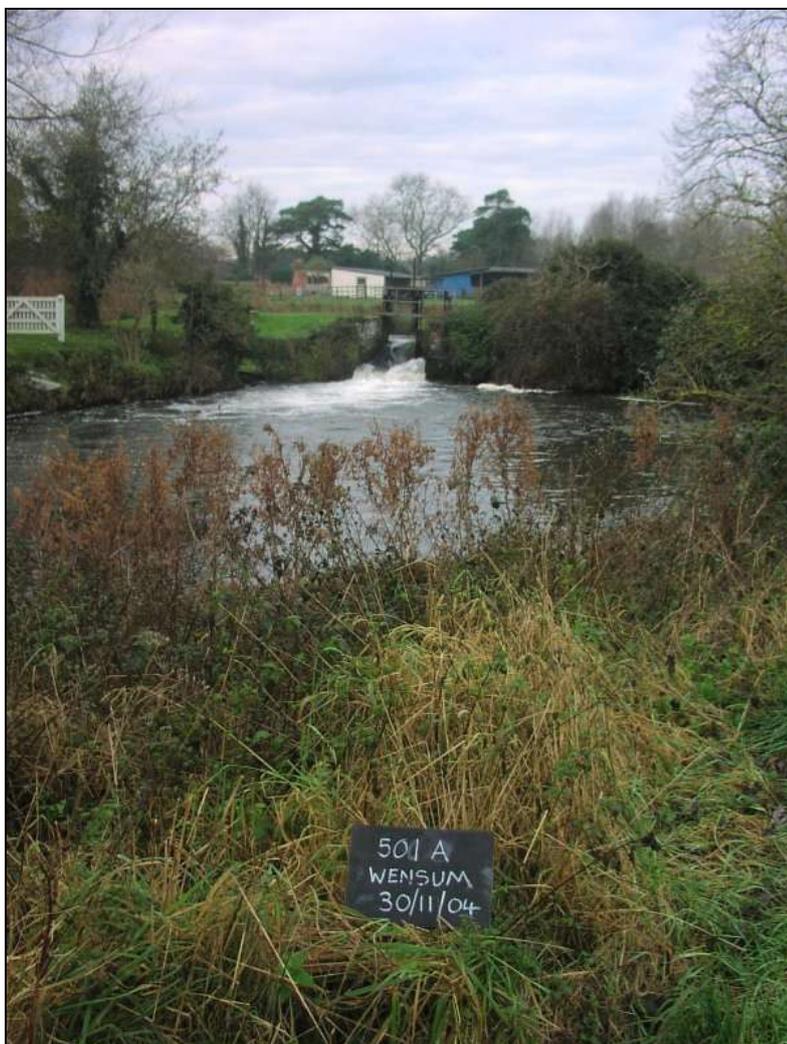
Plate Bh1 View of by-pass sluice at Elmham Mill site from downstream (photo from GeoData, 2006)

Main recommendations:	Existing gates have invert 20.92 and thus suitable for significant reduction in operating level without major modifications. Negotiate lower operating levels progressively using existing sluice control.
-----------------------	--

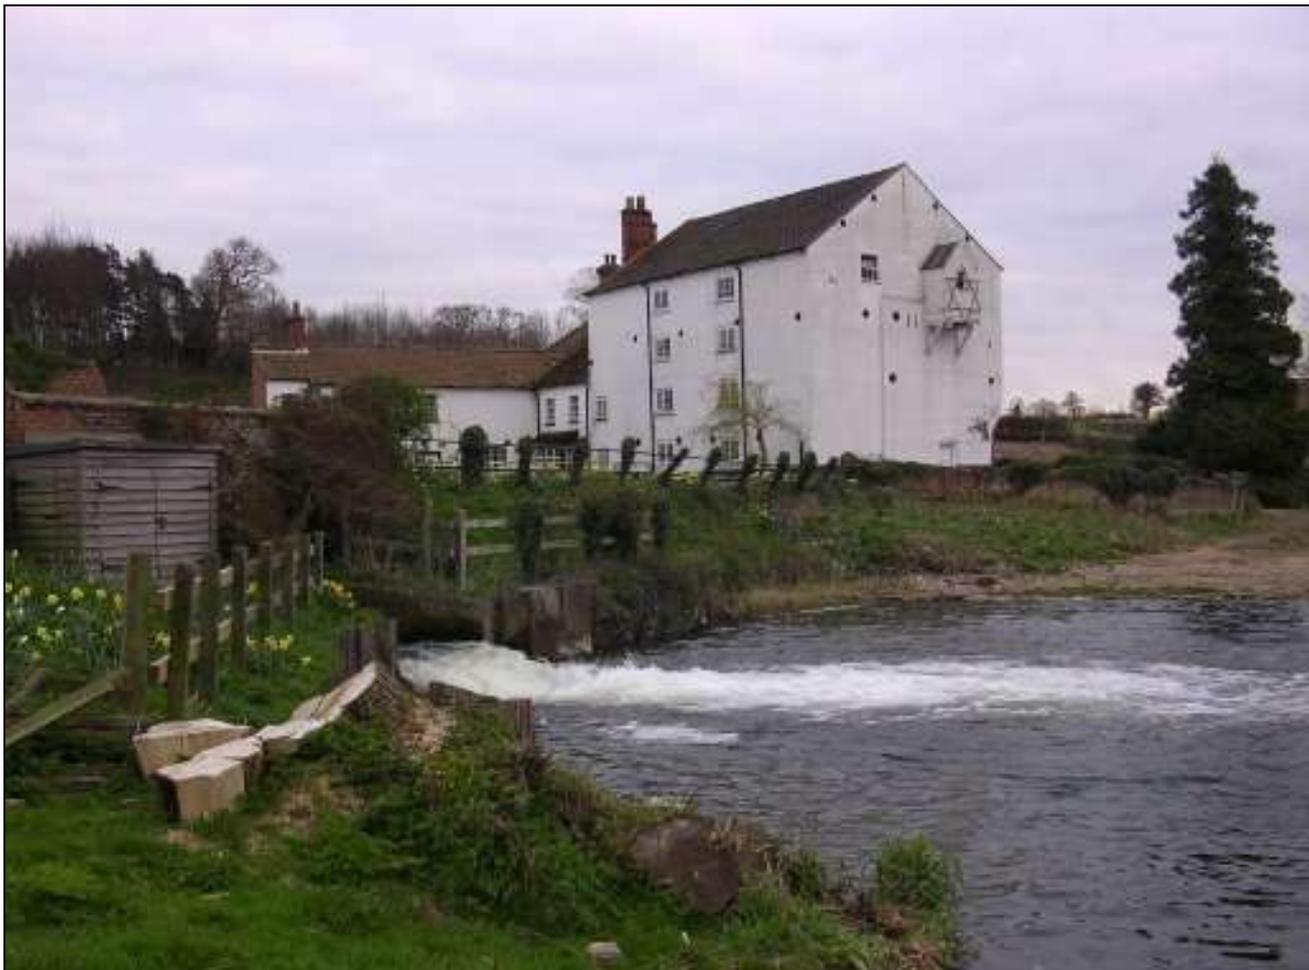
Plate Bi1 View of by-pass channel at Bintry Mill

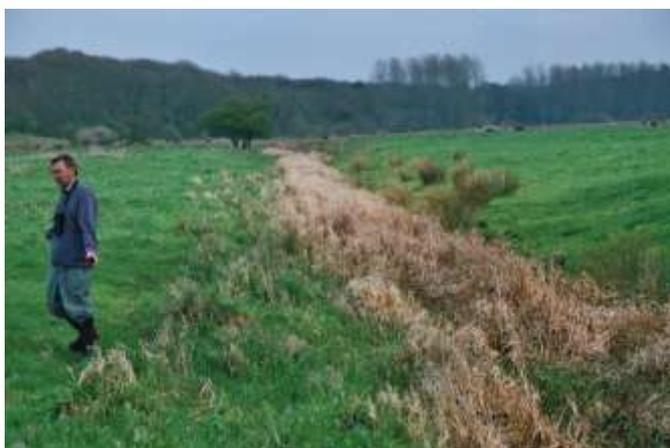
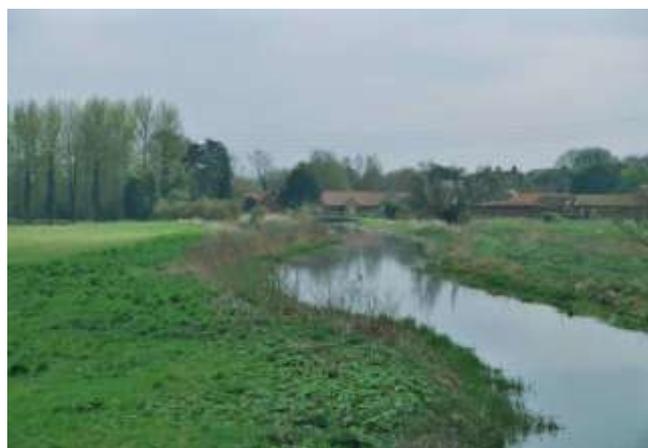
Plate Bj1 Left: View of old channel on left bank of current River Wensum, downstream of Great Ryburgh Mill: Right: View upstream towards Great Ryburgh Mill

Water control level:	30.2m AOD (estimated)
Drop:	2.91m
Length of backwater upstream:	3km (46% reach)
Main structure:	Two vertical lifting gates (29.06m AOD). Gates repaired in 2001.
Operation of main structure:	Gates generally kept open.
By-pass structure:	Fixed weir on left bank adjacent to mill
By-pass structure operation:	None (fixed weir)
Gauging station:	None
Additional notes:	None

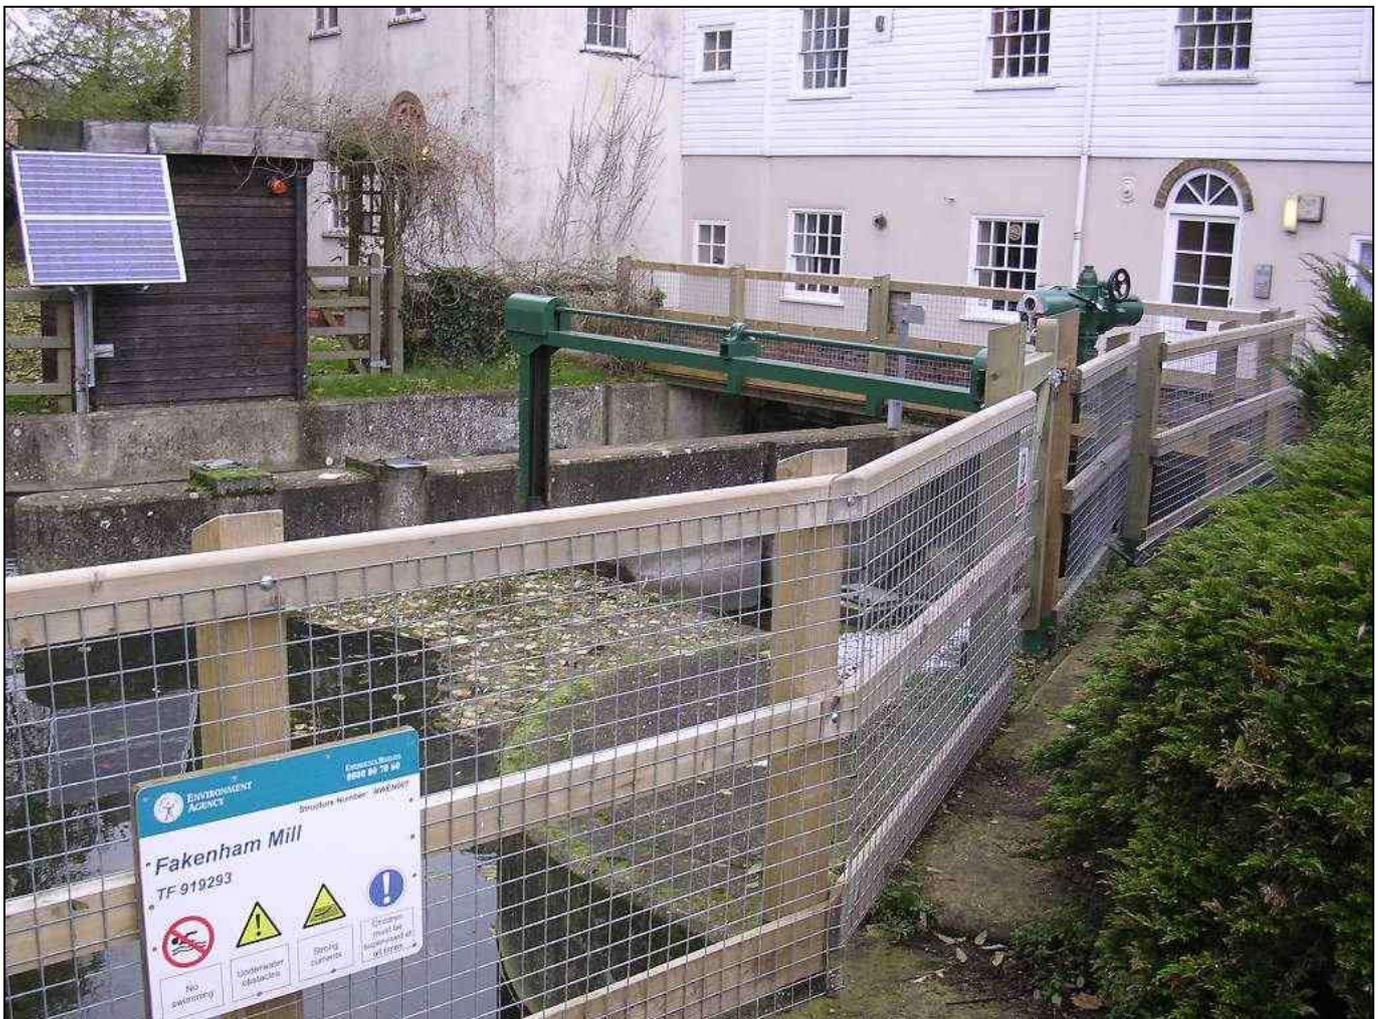
Plate Bk1 View upstream of weir at Fakenham Mill

Main recommendations:	The operating level in summer could be reduced initially by 0.4m by leaving the gate open. Further lowering could be achieved through breaking out the crump profile weir and control gate but this would then be limited by the fixed concrete beneath the mill. The bed level immediately upstream of the mill is close to weir level whereas further upstream according to survey sections (1980s) it is over 1m deeper. Silt control in this reach is thus likely to be important.
-----------------------	--

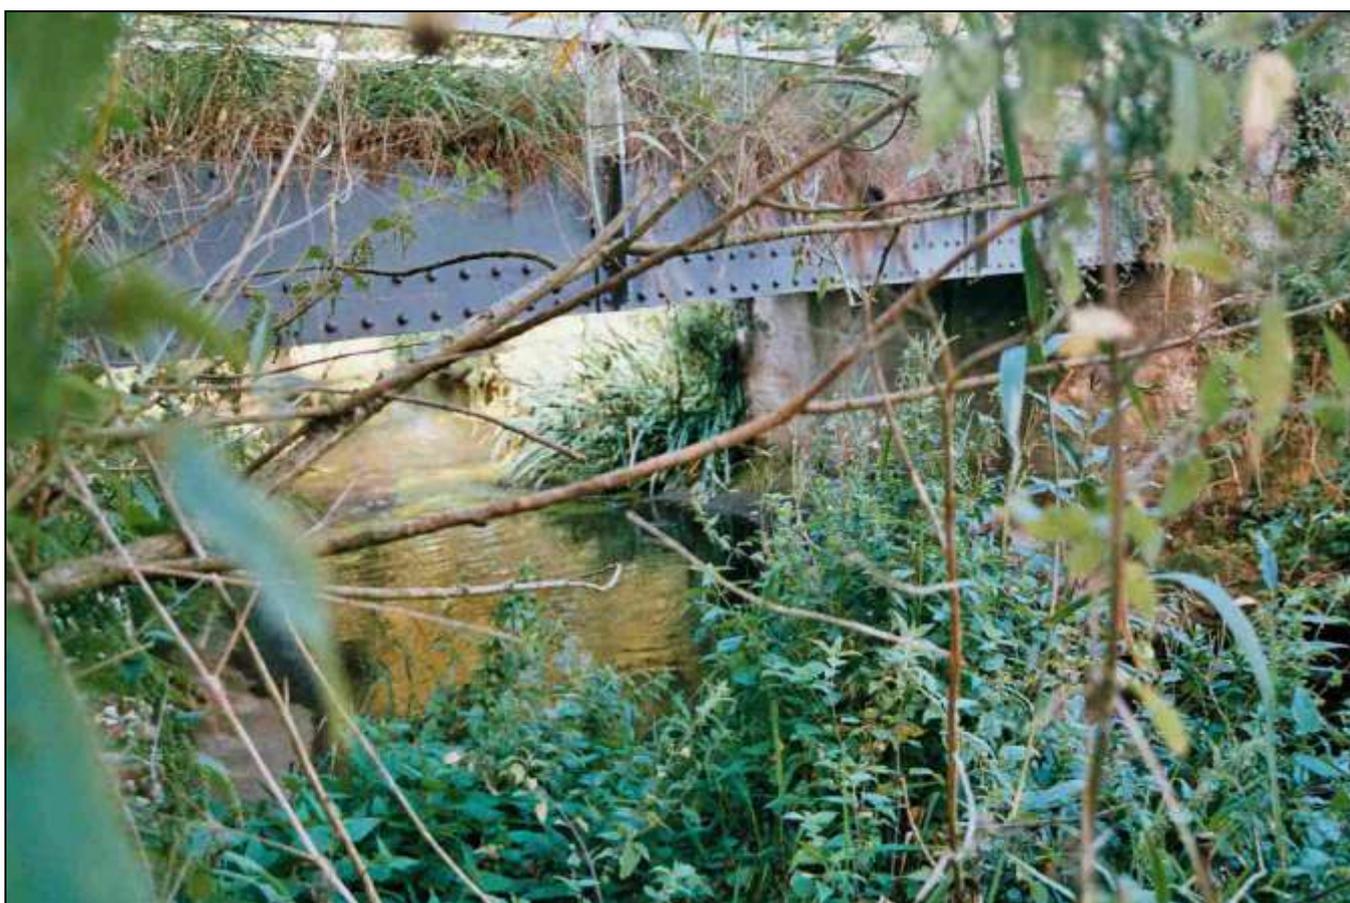
Plate Bm1 View of sill on bed at site of South Mill

Main recommendations:	The hard sill beneath the road bridge does not impact significantly on upstream water levels so no action is proposed.
-----------------------	--

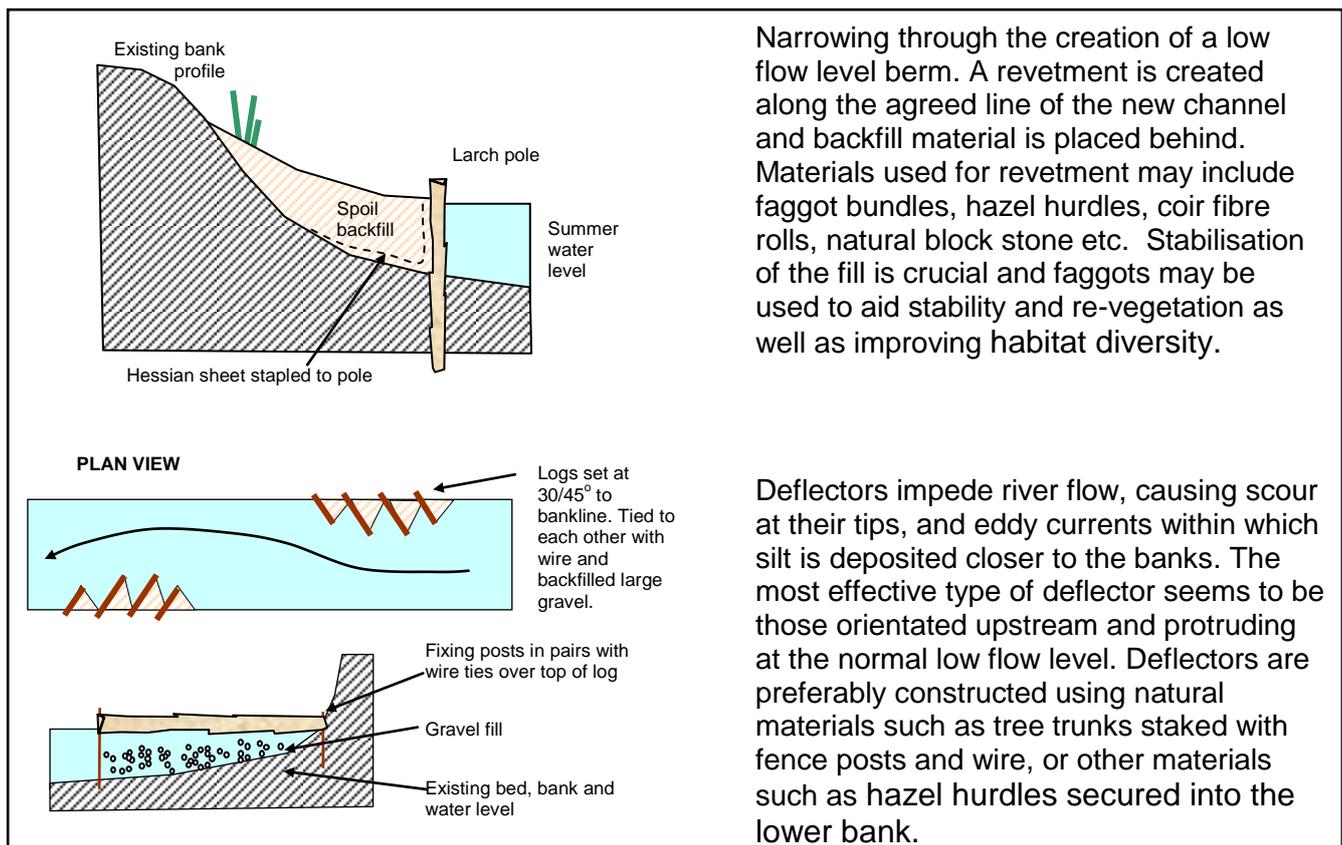
Narrowing through the creation of a low flow level berm. A revetment is created along the agreed line of the new channel and backfill material is placed behind. Materials used for revetment may include faggot bundles, hazel hurdles, coir fibre rolls, natural block stone etc. Stabilisation of the fill is crucial and faggots may be used to aid stability and re-vegetation as well as improving habitat diversity.

Figure E1 shows an example of each of these methods. However, there are many variations on these methods related to the materials that can be used, the extent and type of narrowing required, the existing habitats present and the placement of the revetments, deflectors and planted vegetation.

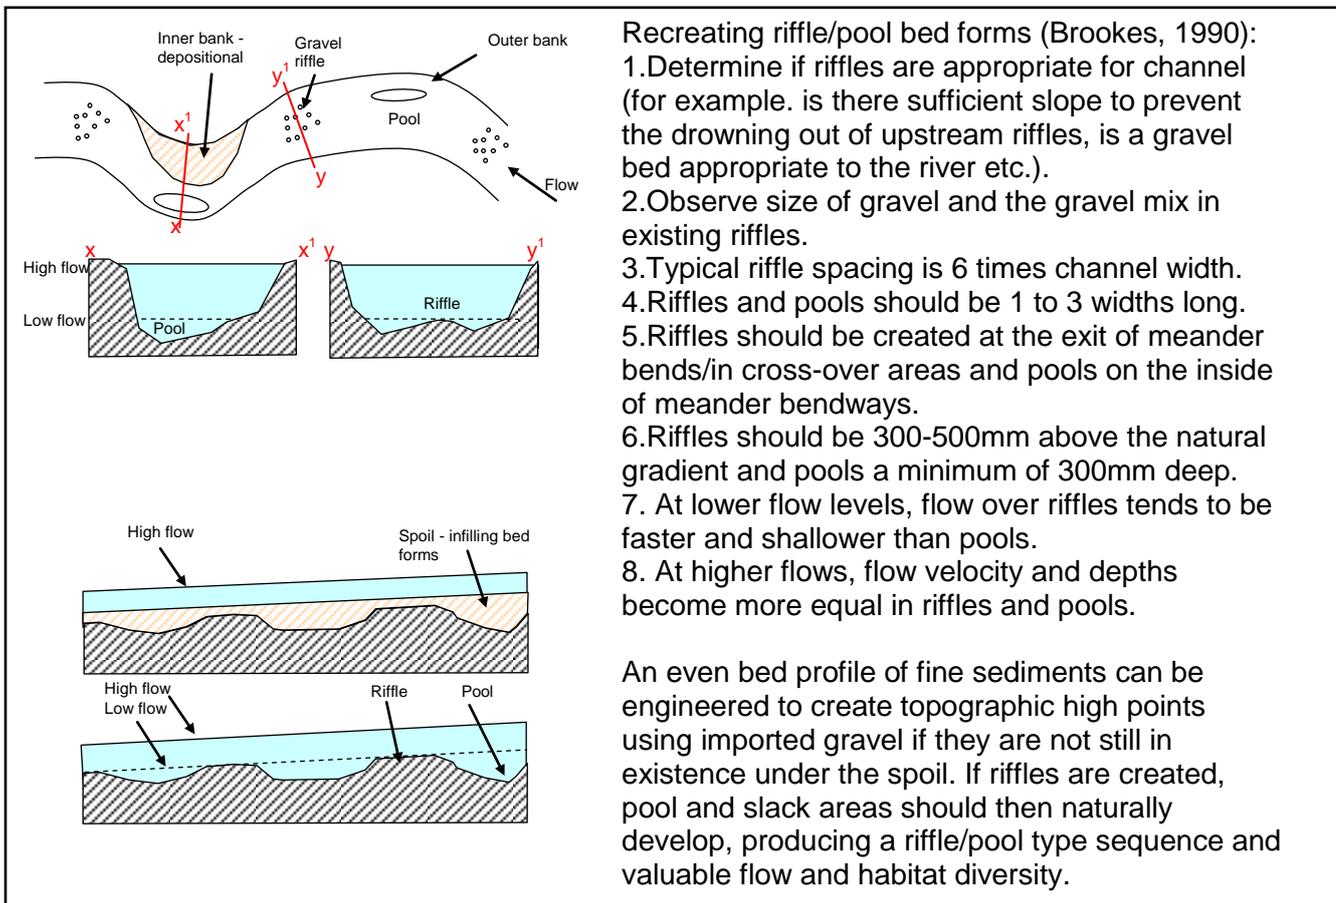
Figure E2 Creating riffle/pool sequences (adapted from Knighton, 1998)

Given that the River Wensum is a low energy stream, it will be important that the shape and extent of any placed gravels are suitable to generate appropriate flow paths and local velocity distribution profiles. The stream energy will not generally be capable of redistributing existing gravel bed materials and such materials are relic features that cannot be reproduced by the catchment. The River Restoration Centre have stated that, in the Wensum, the location and type of gravel bed augmentation must be assessed on a case-by-case basis by experienced geomorphologists following a site visit. It is also likely that adaptive management of these features will be required to ensure that they function as required and a cautionary approach needs to be taken in relation to the importation of restoration designs from elsewhere.

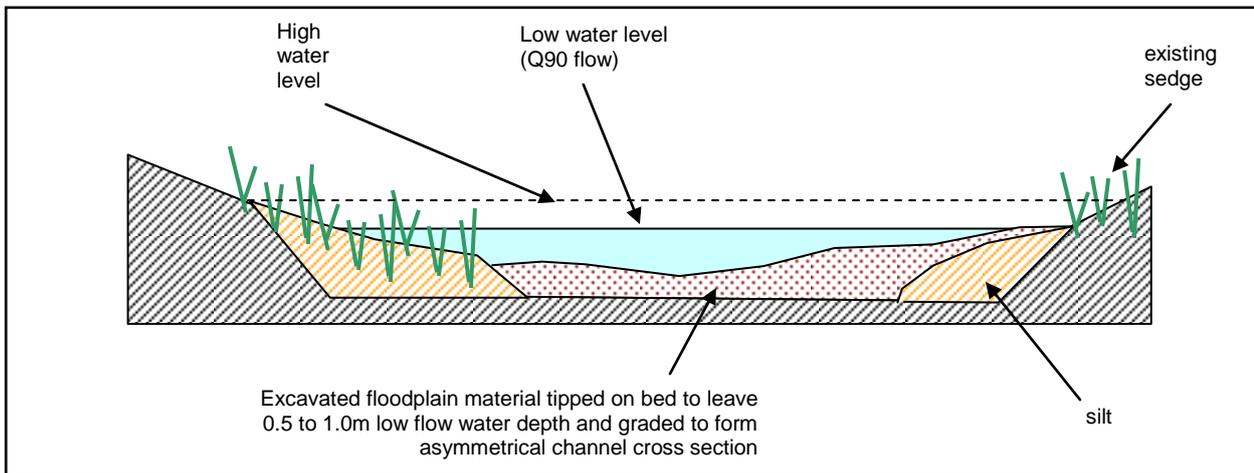
Figure E3 Bed raising on the River Kennet

Bed raising has been used at a number of locations on the River Kennet, including Mill Lane Ford where a more natural width to depth ratio was needed (Figure E3). The bed was raised asymmetrically (different depths across the channel) to ensure a narrow low-flow meandering course and shallow edges that encourage marginal vegetation encroachment. Bed levels were increased so that at low flow the depth was 0.5 to 1.0m (based on the Q90 discharge levels - the level at which flows are exceeded 90% of the time). Gravel flints obtained from the floodplain adjacent to the river were used to raise the bed as such material was assumed to be representative of natural bed sediments. After 2 years, the reconfigured channel had typical chalk stream habitat, with a self-cleansing gravel bed that is used by trout for spawning.

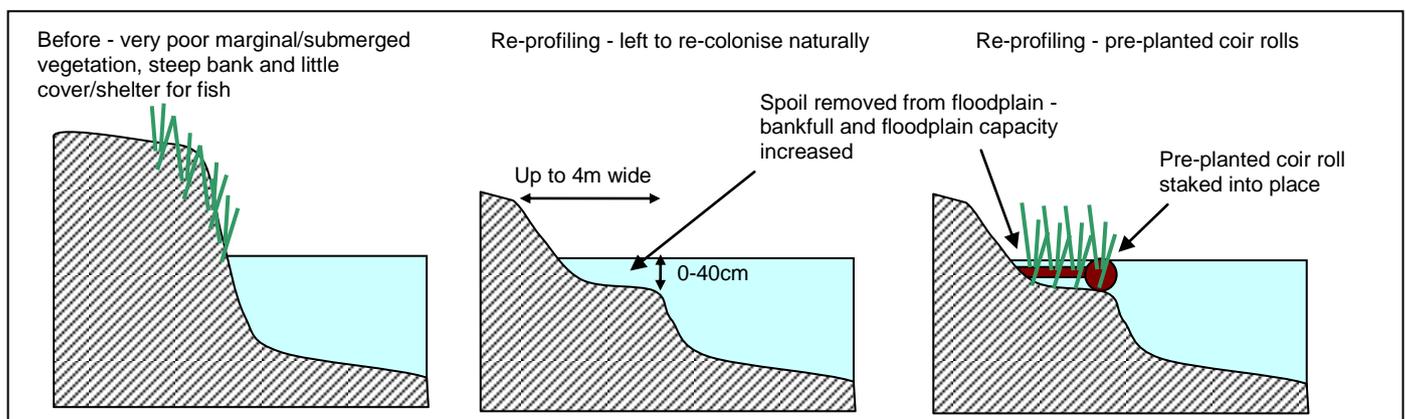
Figure E4 Bank re-profiling at Swanton Morley (Phase 3)

At Swanton Morley (Phase 2), a section of the left bank was re-profiled to create a wet margin (1m wide by 40m long). At Swanton Morley (Phase 3) extensive stretches of the right bank were re-profiled to form a range of submerged and wet shelves. Portions of the bank were planted with vegetation from elsewhere on site and some were covered with pre-planted coir rolls (Figure E4).

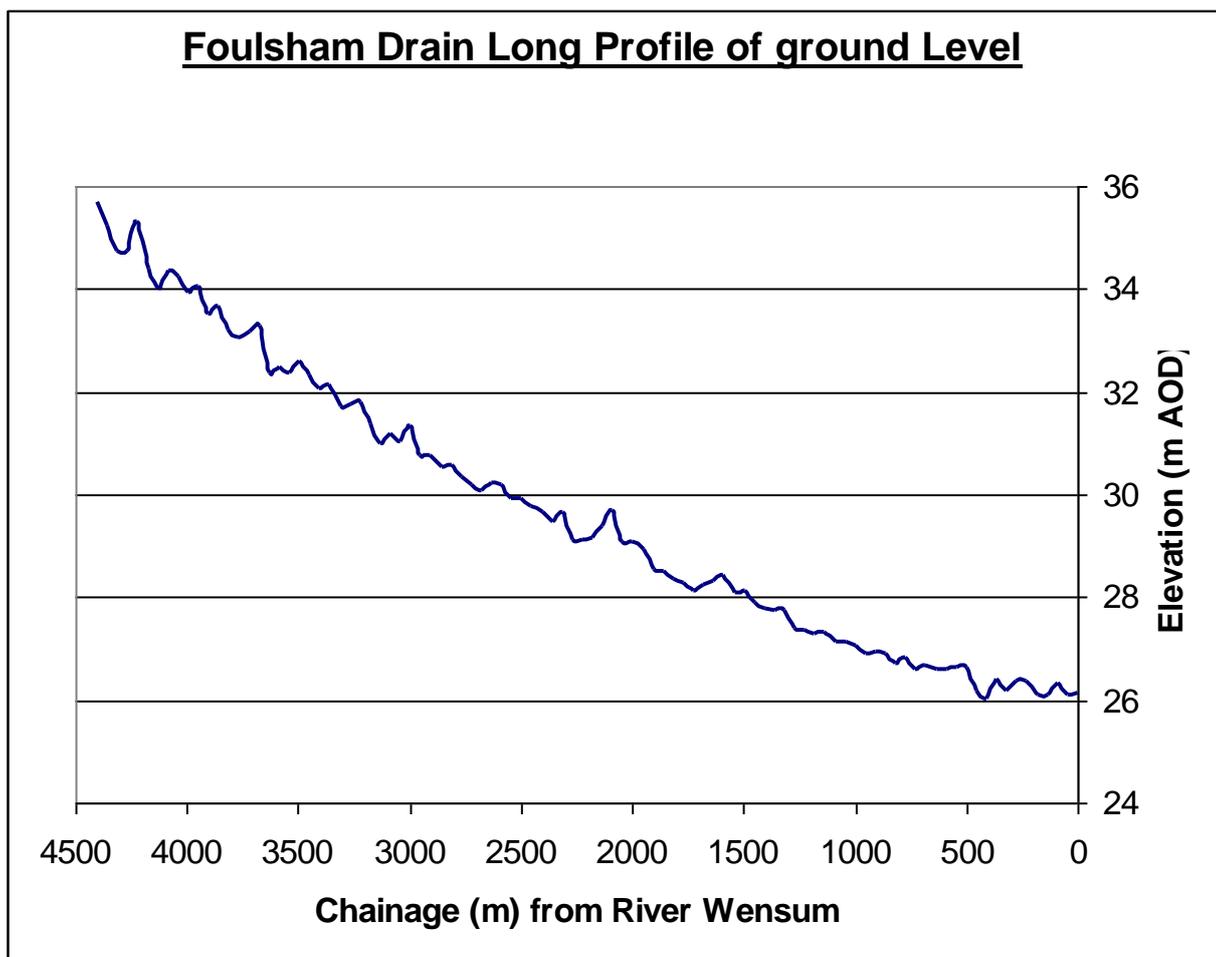
Figure 11 Long profile of ground along route of IDB drain to Foulsham

There was not any detailed information or survey of drains but drain sizes can be estimated and the long section generated by consideration of the land levels along the route of the drain.

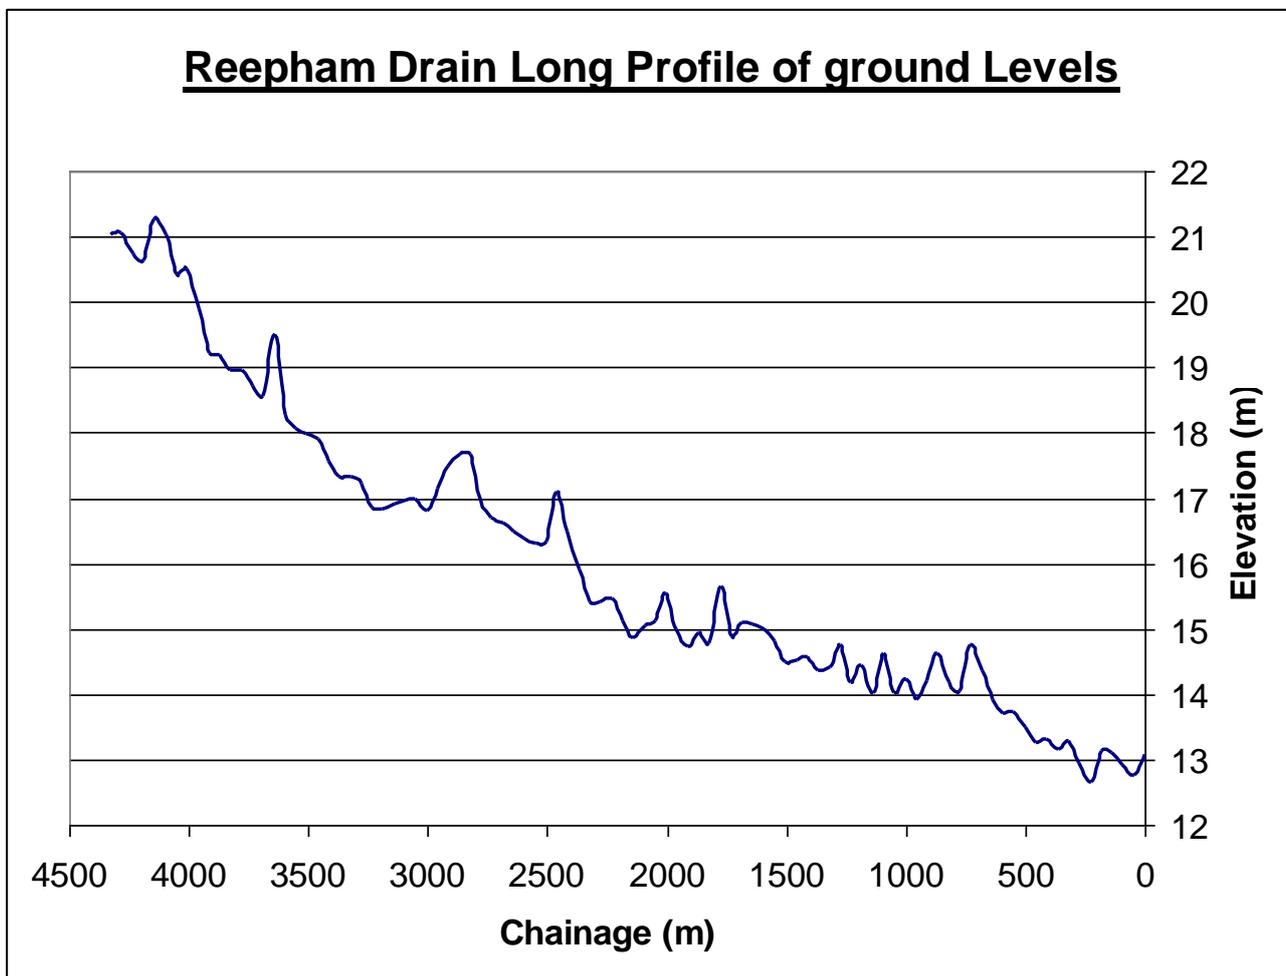
Figure I2 Long profile of ground along route of IDB drain to Reepham

The influence of a potential change in River Wensum flood levels of at most the order of 0.5m (due to bed raising and narrowing) at the discharge point of the drain on the settlements can thus be illustrated by backwater analysis.

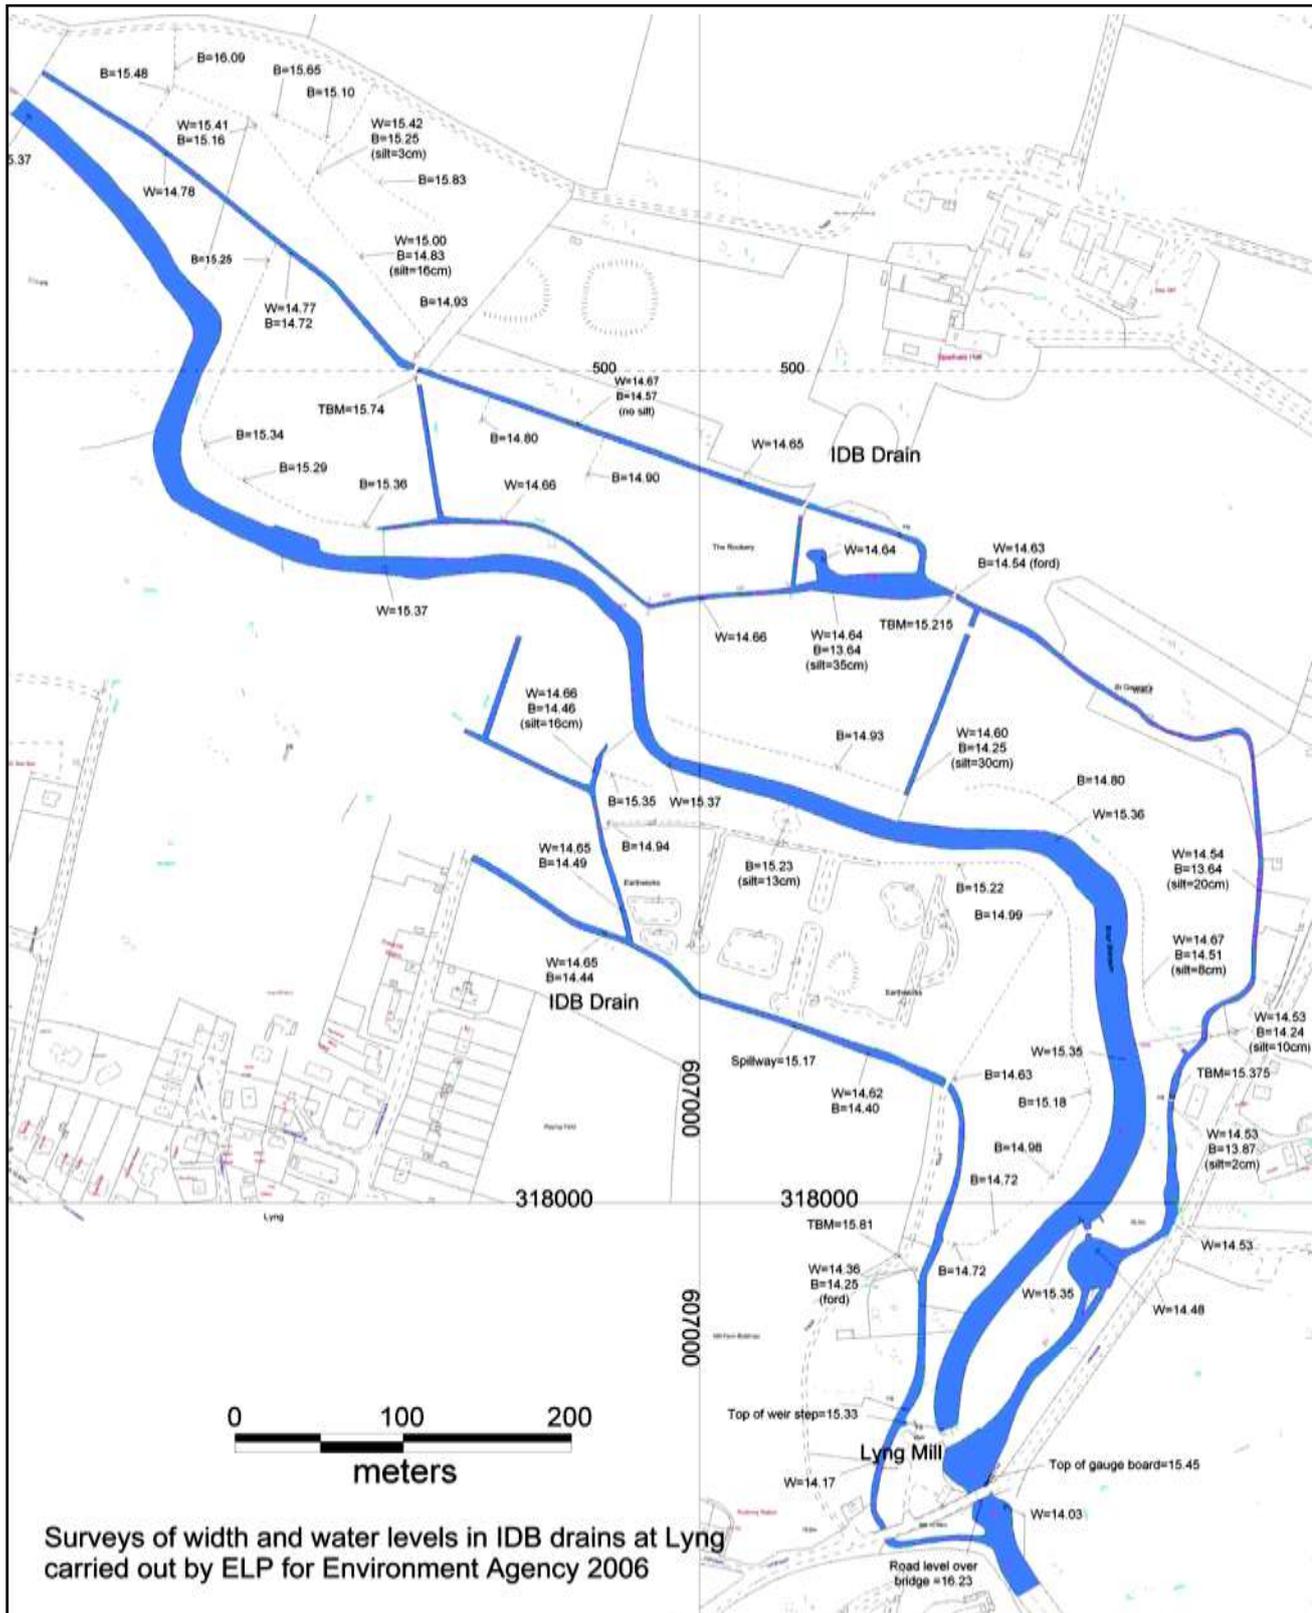
Figure I3 IDB Drains survey at Lyng by ELP in 2006 showing drain widths and water levels

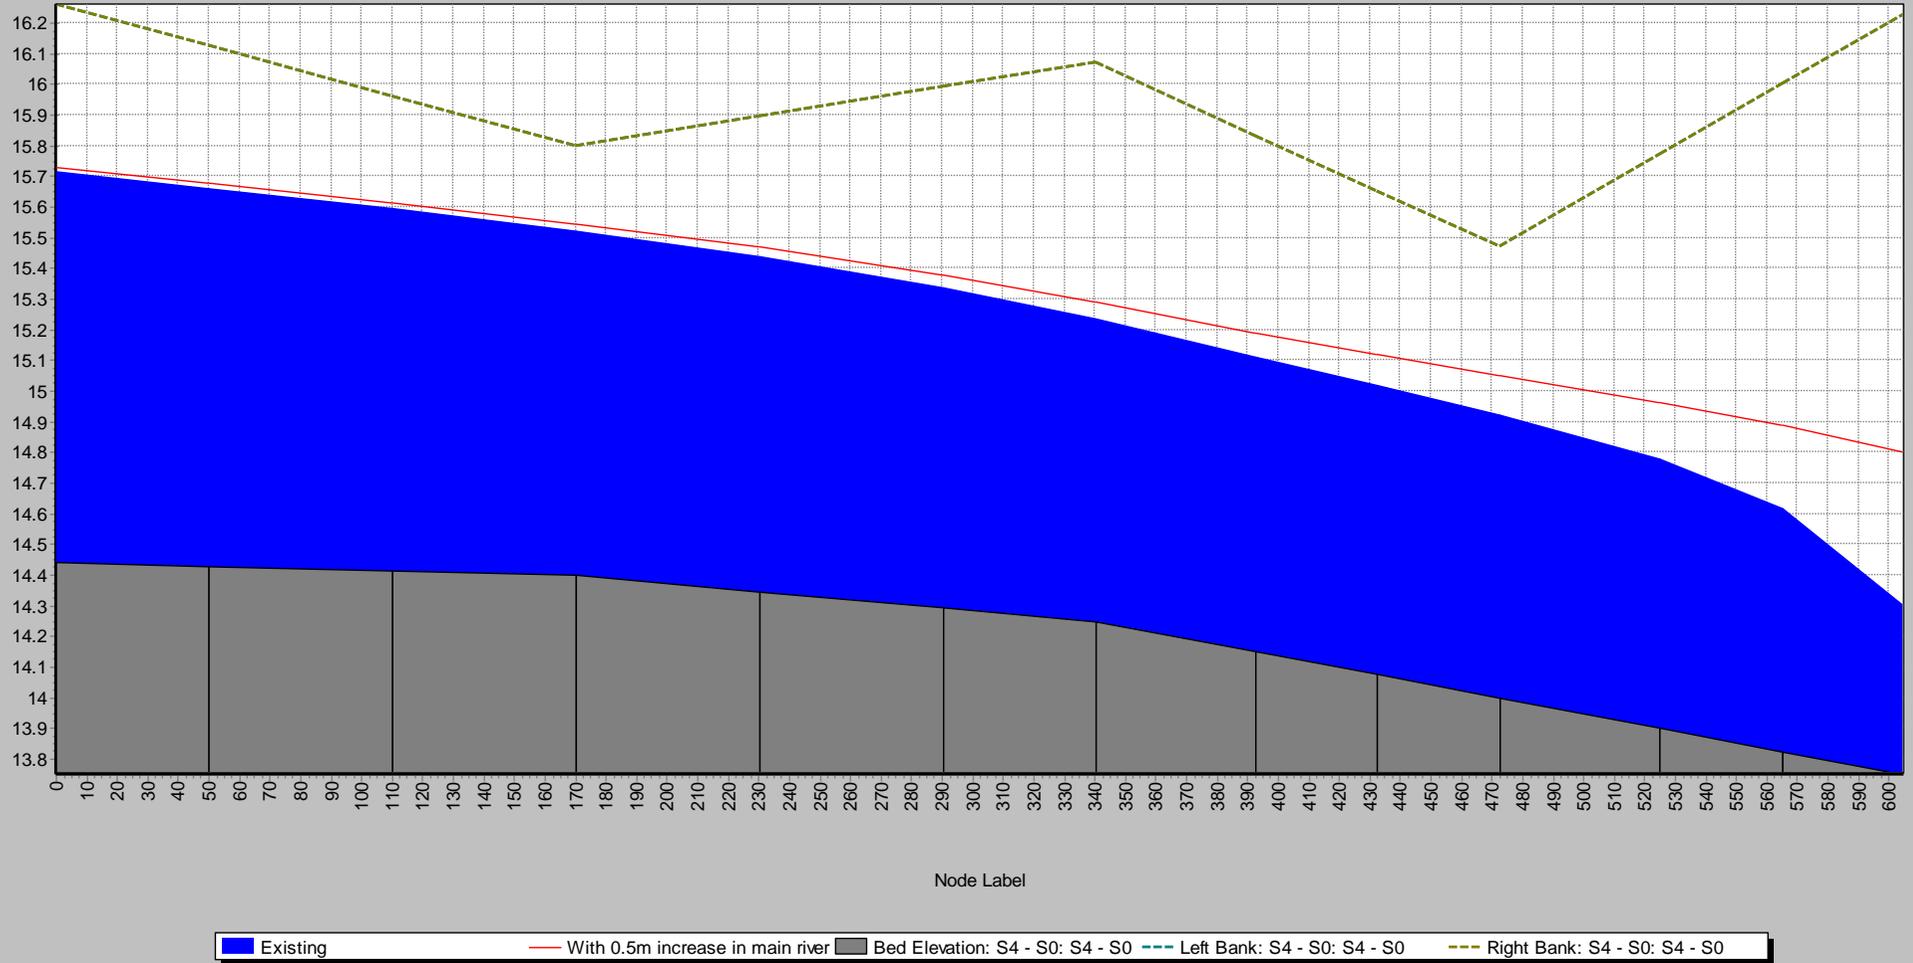
Long Section: S4 - S0 - Stage; 0 - 2 h.

Solid colouring indicates current condition and the red line the water level with the restoration of the river in place.

conditions in the River Wensum and for the future conditions with restoration. Applying this to the drain the results are shown in Figures I4 and I5. Both of the drains have high water level gradients as they approach the Wensum and thus the backwater effect is limited in both cases.
