Appendix 2 Mill summary sheets

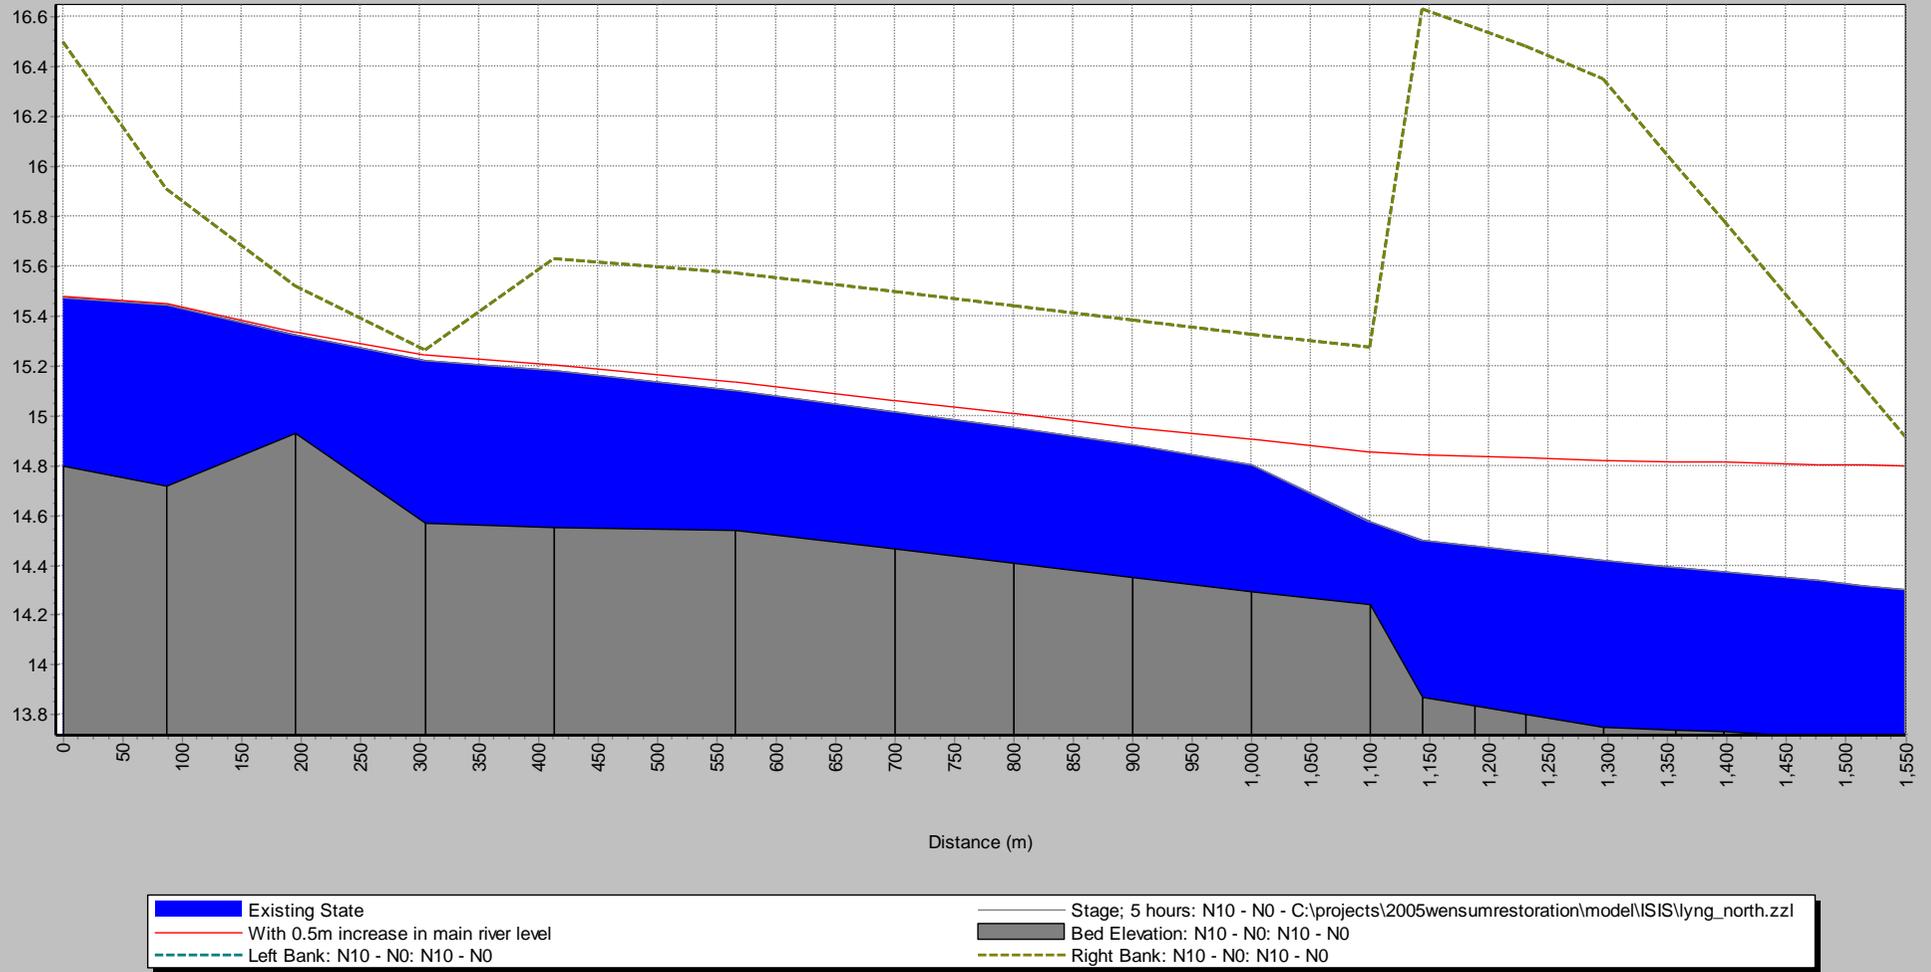
Long Section: N10 - N0 - Stage; 0.000 h.

Figure I5 Sensitivity of IDB drain water level (North channel at Lyng)

conditions in the River Wensum and for the future conditions with restoration. Applying this to the drain the results are shown in Figures I4 and I5. Both of the drains have high water level gradients as they approach the Wensum and thus the backwater effect is limited in both cases.

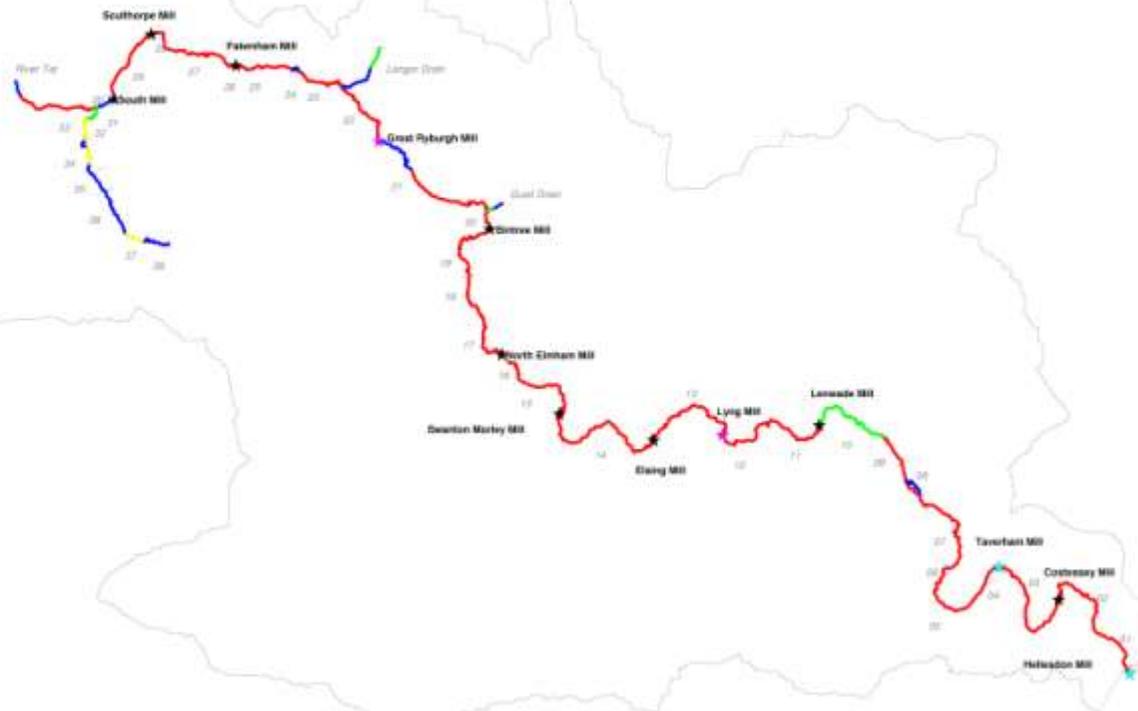
River Wensum Catchment	
Mills - lower	
Mills - remove	
Mills - bypass	
Restoration	
Rehabilitation	
Enhancement	
Assist Natural Recovery
